Charlestown Conservation Area Character Appraisal and Management Plan

2020

The document was commissioned by St Austell Bay Parish Council and prepared by Cornwall Archaeological Unit, Cornwall Council.

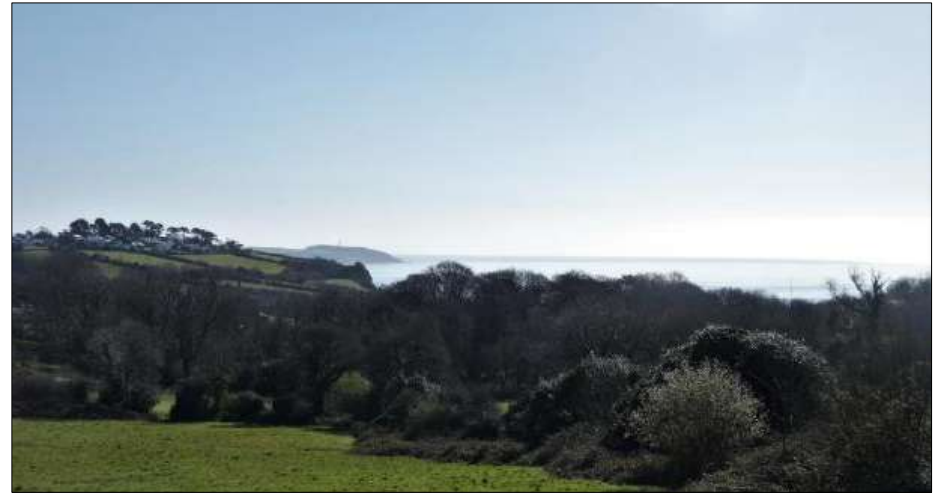
The view south east across Charlestown from immediately outside the north-west boundary of the Conservation Area. The historic settlement's green setting means that only a few roofs and the upper portion of the early twentieth-century stack of the Lovering clay dry are visible from this direction. Gribbin Head with its daymark tower is prominent in the distance.

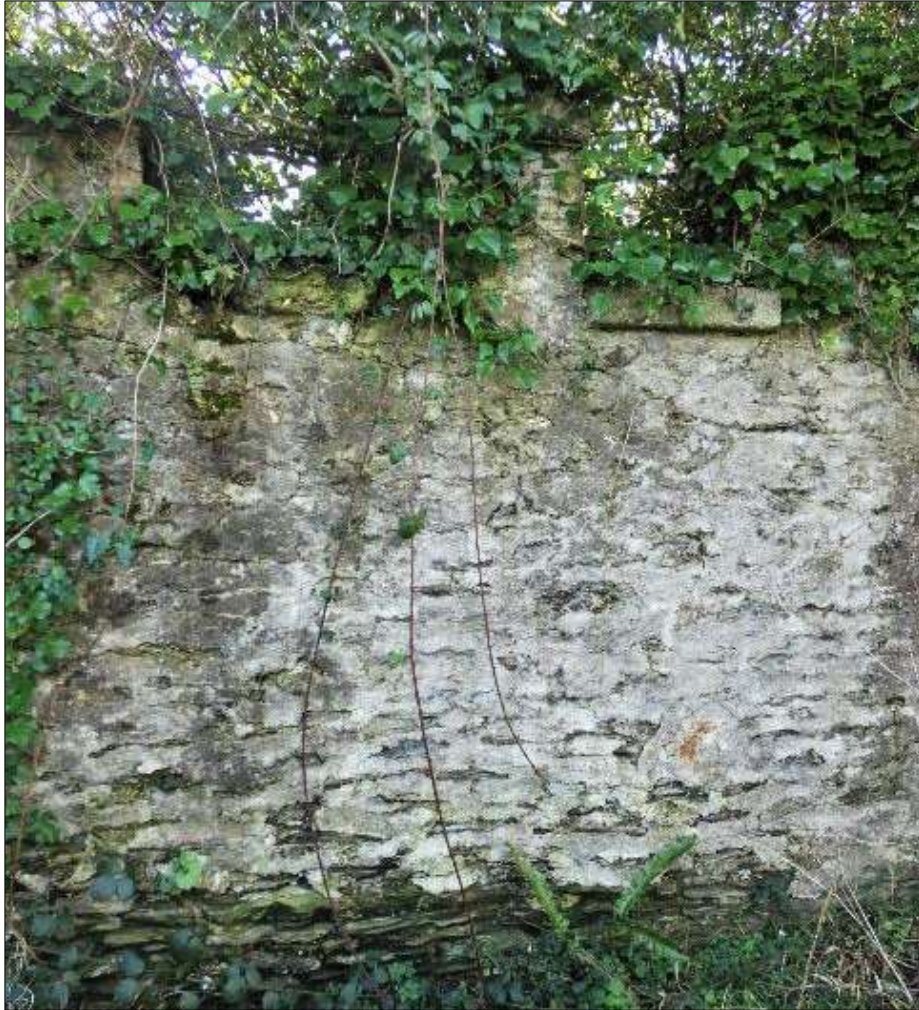
The gun battery at Crinnis Head has crenellated walls on its landward side, possibly constructed for decorative purposes, to be viewed from Charles Rashleigh's estate at Duporth.

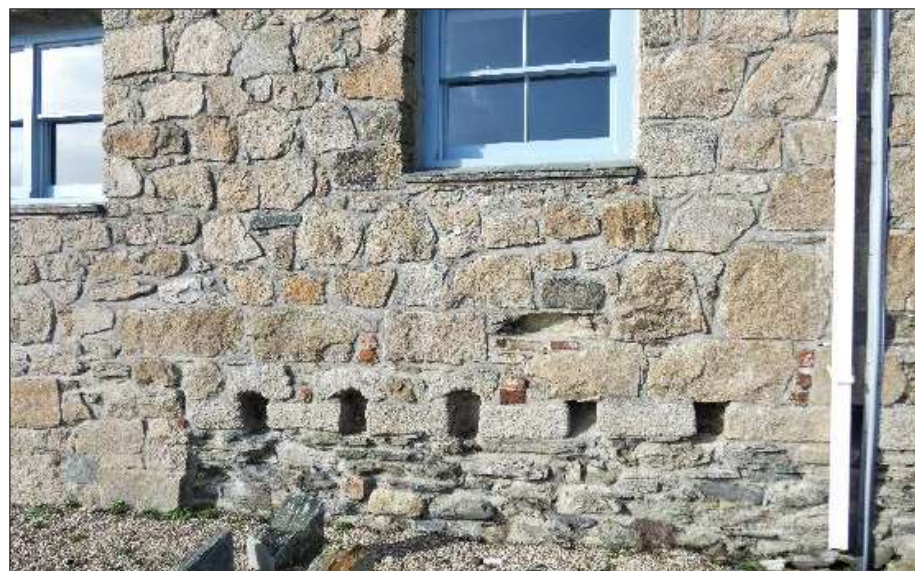
Surviving press pole sockets in the wall of the former pilchard cellar at 1 Quay Road (Salamander), now converted to holiday accommodation. The original building pre-dated the development of Charlestown.

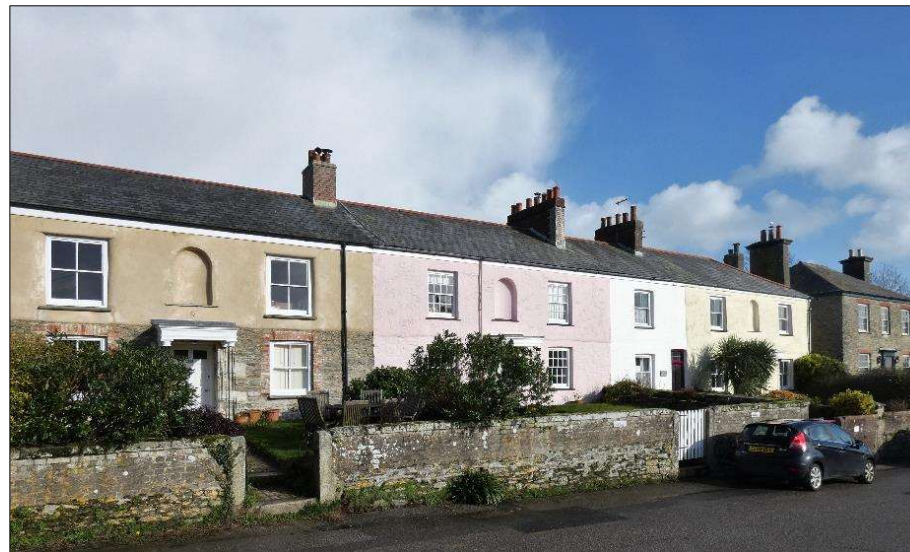
Nos 12-15 Quay Road, built between 1825 and 1842.

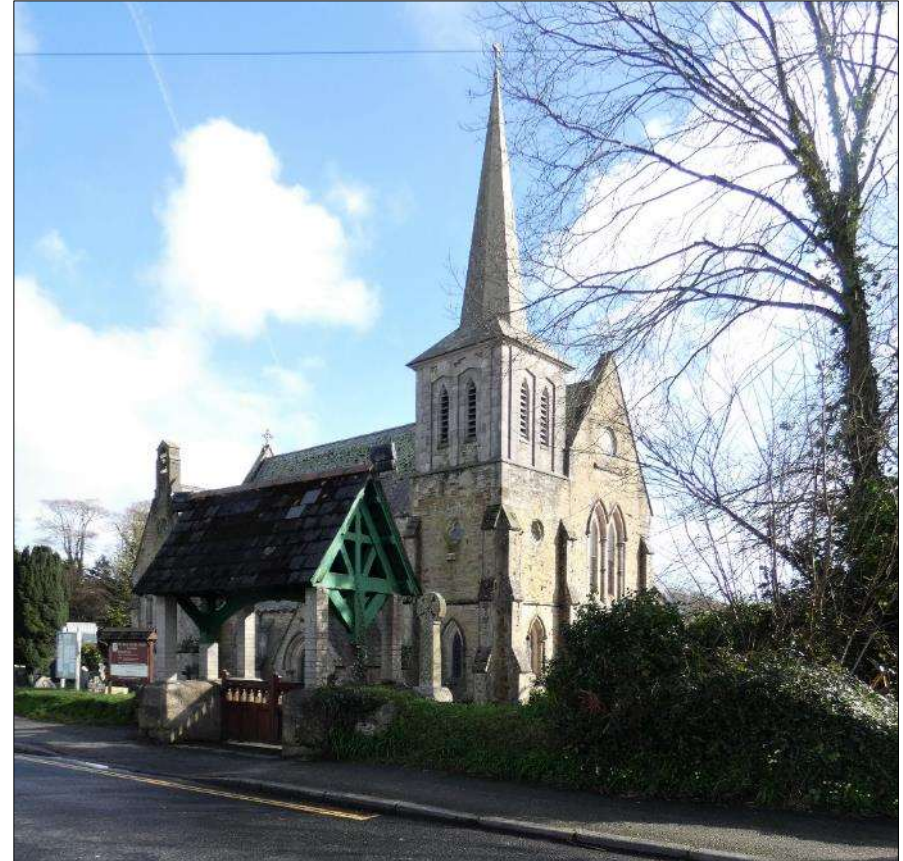
St Paul's church was completed in 1851, designed by the architect Christopher Eales in the Early English Gothic style; the spire was added in 1971.

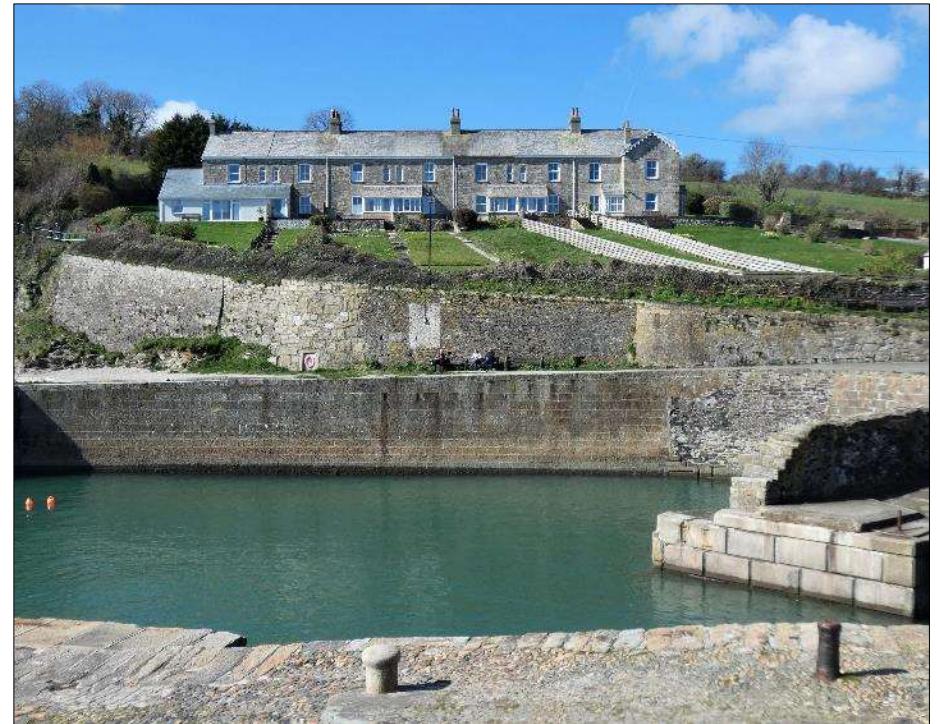
The row of coastguard cottages built in 1892 overlooking the outer harbour.

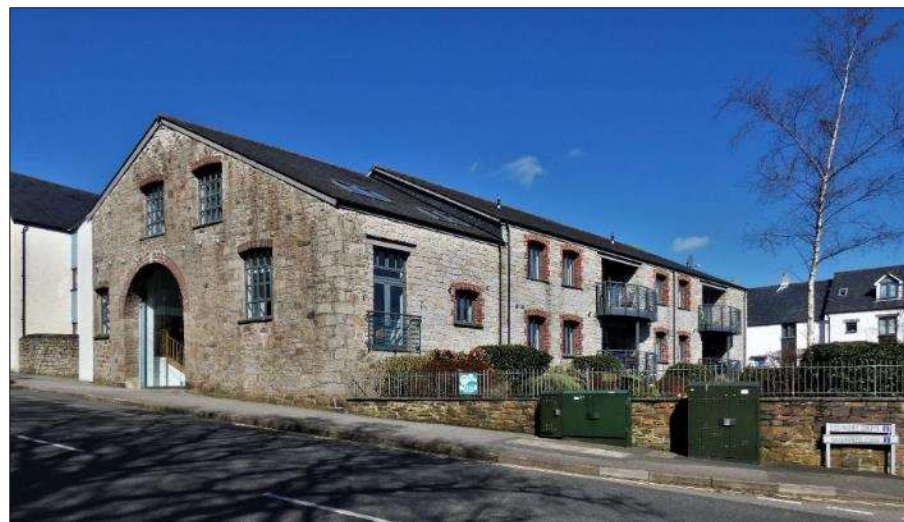
The façade to one of the former Foundry buildings retained as part of the early twenty-first century redevelopment of the site.

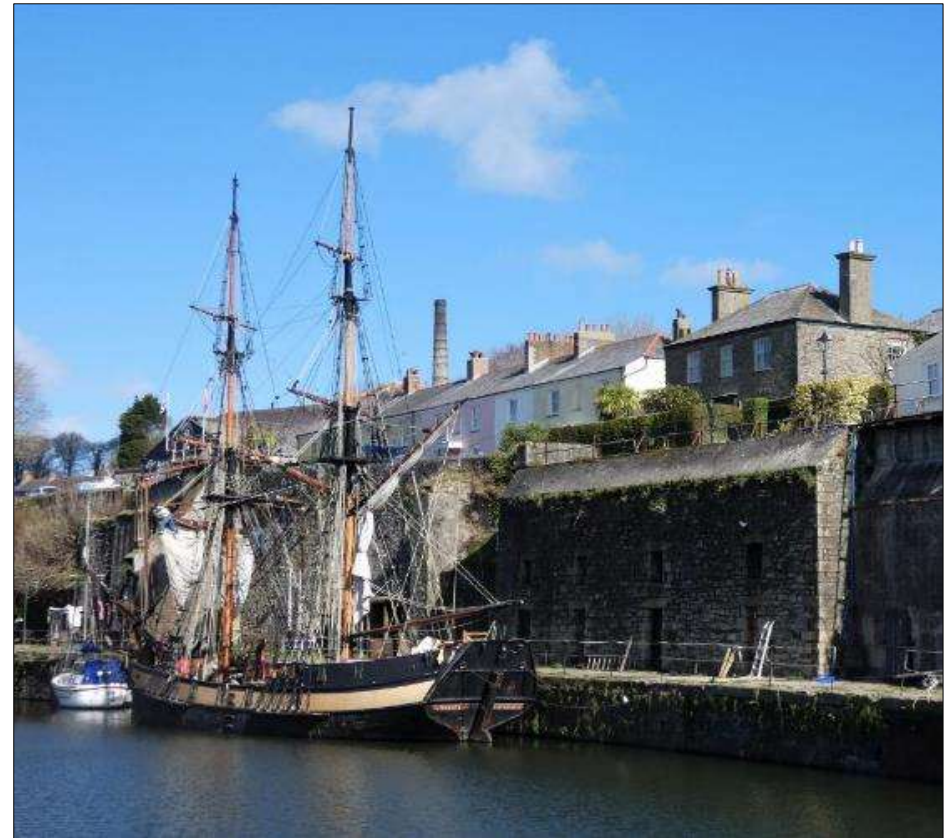
Surviving historic china clay loading structures and the prominent nearby stack of the former Lovering china clay dry emphasise the harbour's historic industrial functions.

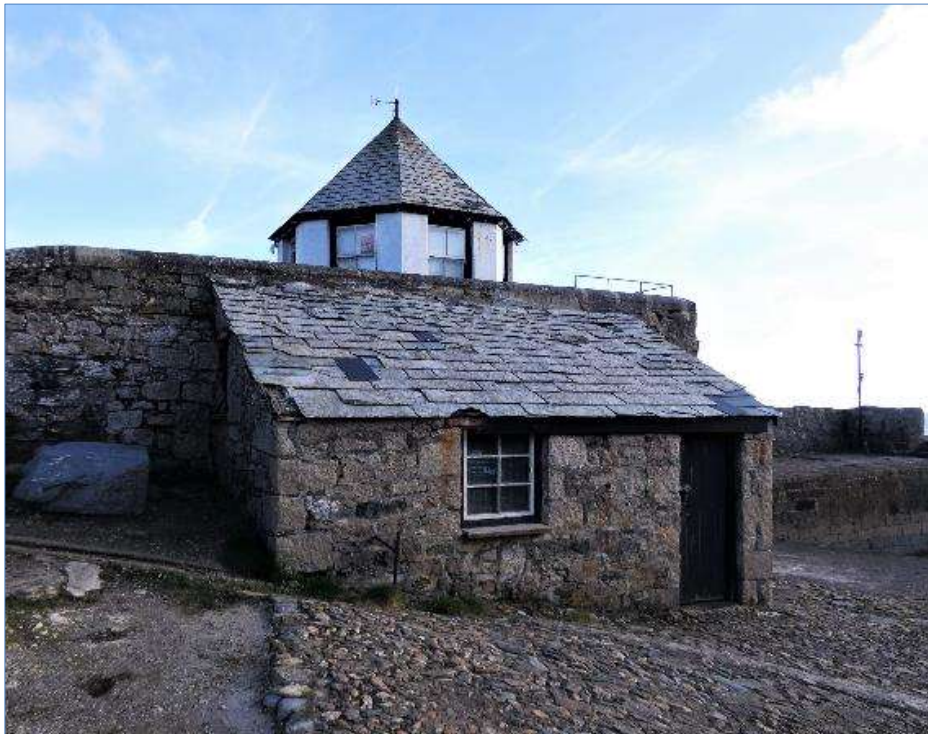
Granite and slate building materials and distinctive water-rounded surfacing on the site of the former lime kiln at the harbour.

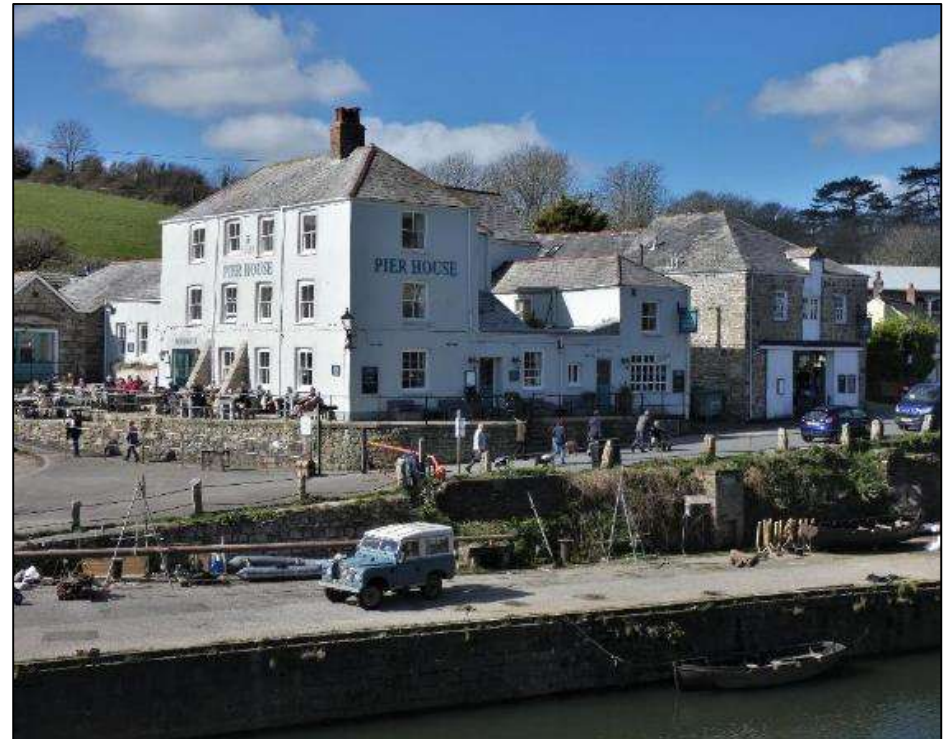
The late eighteenth-century three-storey Pier House Hotel is a focal point of the harbourside area.

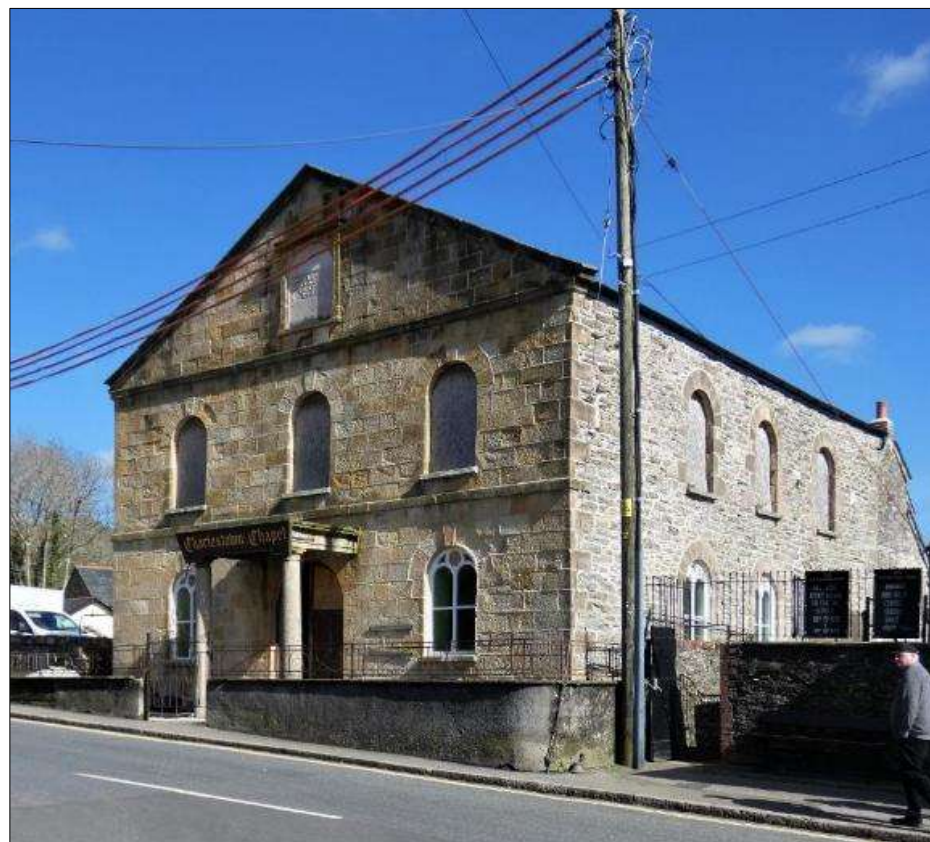
The Grade II Listed Wesleyan Methodist chapel, constructed in 1827 and recently the subject of a major refurbishment project. Obtrusive overhead cabling unfortunately detracts from the view of the façade.*

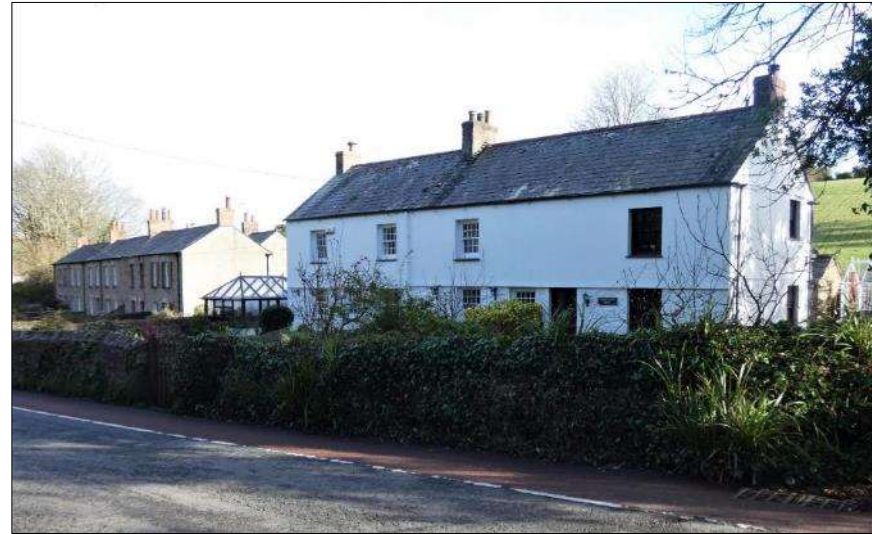
A terrace and cottage row on Duport Road dating to between 1825 and 1842.

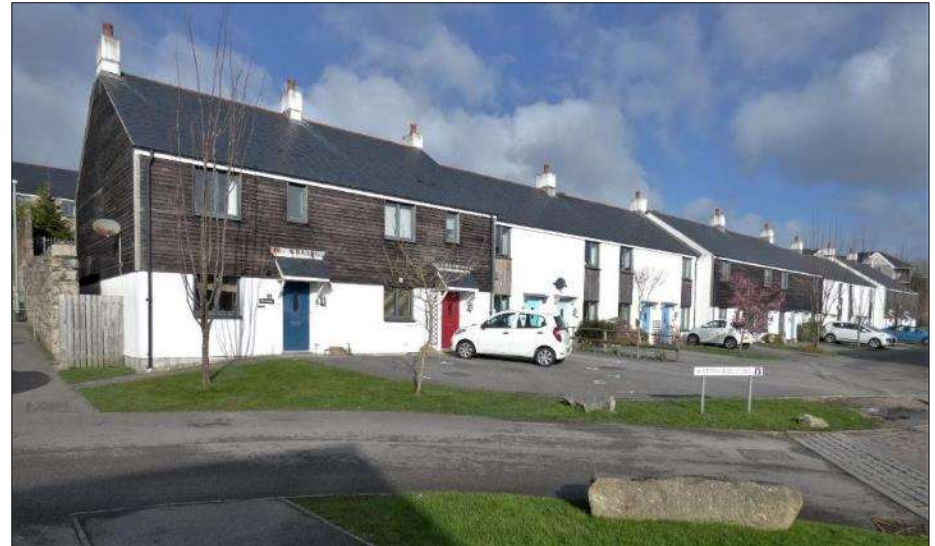
New housing within the redeveloped former foundry site. Part of the former boundary wall to the industrial complex has been retained to the rear.

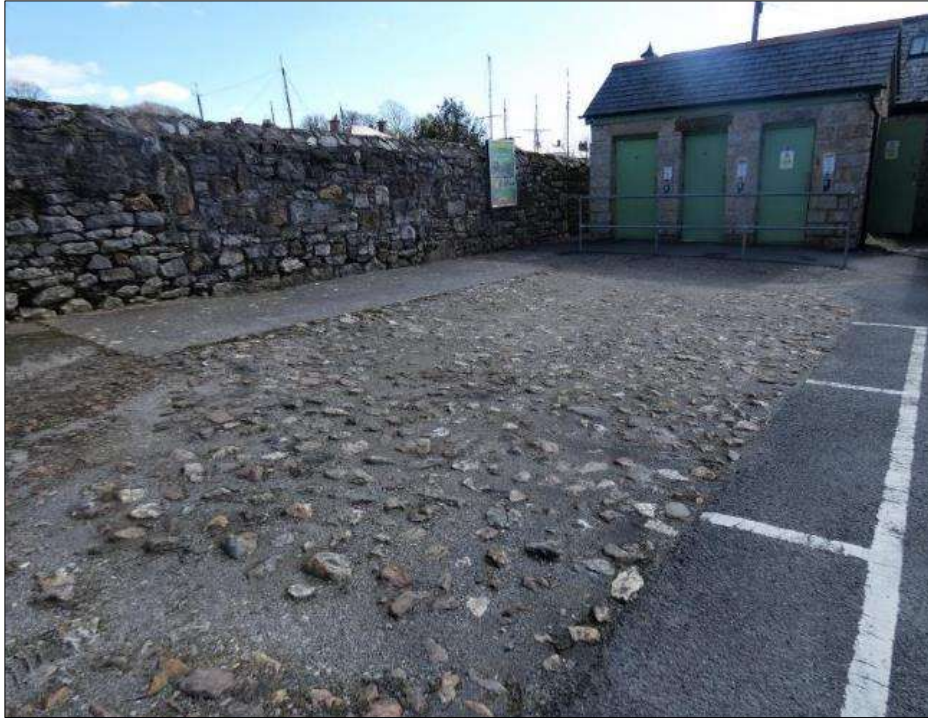
The main car park in Charlestown was formerly a coal and timber yard; small areas of its original cobbled floor remain visible.

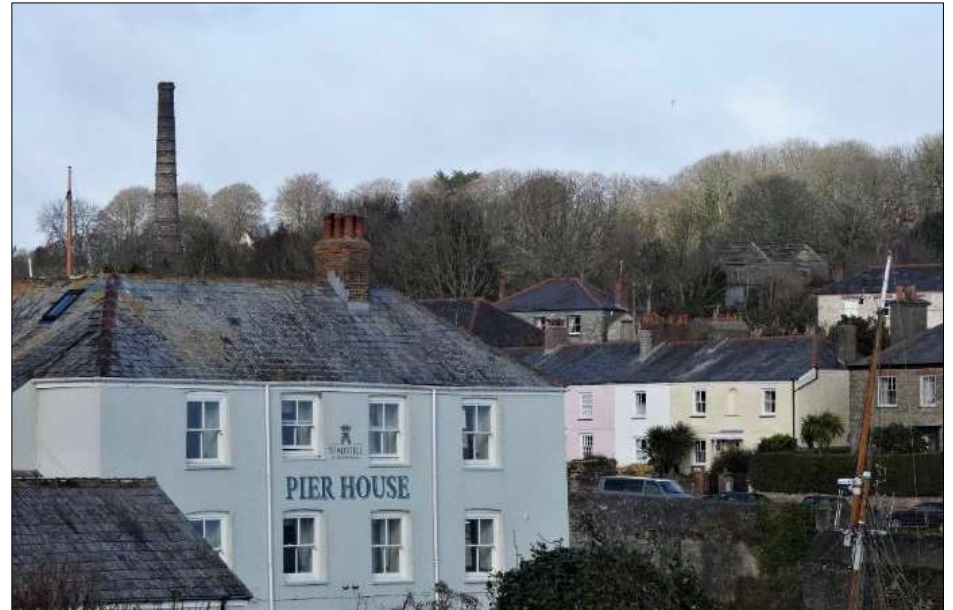
The early twentieth-century chimney of the Lovering china clay dry, rising above the surrounding rooftops, is a conspicuous element in many views in the southern part of the settlement.

The tall chimney of the Lovering china clay pan kiln of 1907-08 is a prominent landmark in the village, although much of the associated dry with its characteristic long, low form has been demolished. This complex included a number of technical innovations, including a pipeline from the Carclaze pit for the movement of clay slurry to the dry and a tunnel and tramway system connected to the harbour for the transportation of the dried clay blocks for loading onto vessels in the harbour. A portion of the former linhay of the dry is to be preserved as a heritage asset associated with the tunnel link to the harbour.

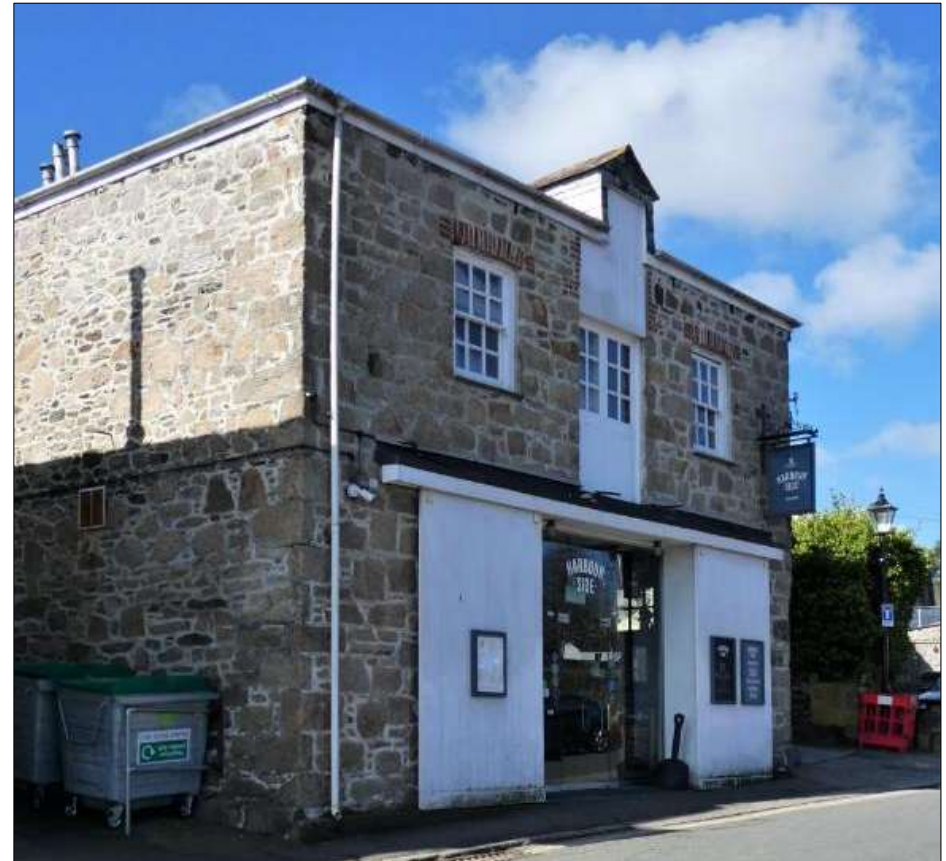
Former use as a warehouse can be read in the surviving large ground floor opening and gable dormer which would originally have housed a hoist.

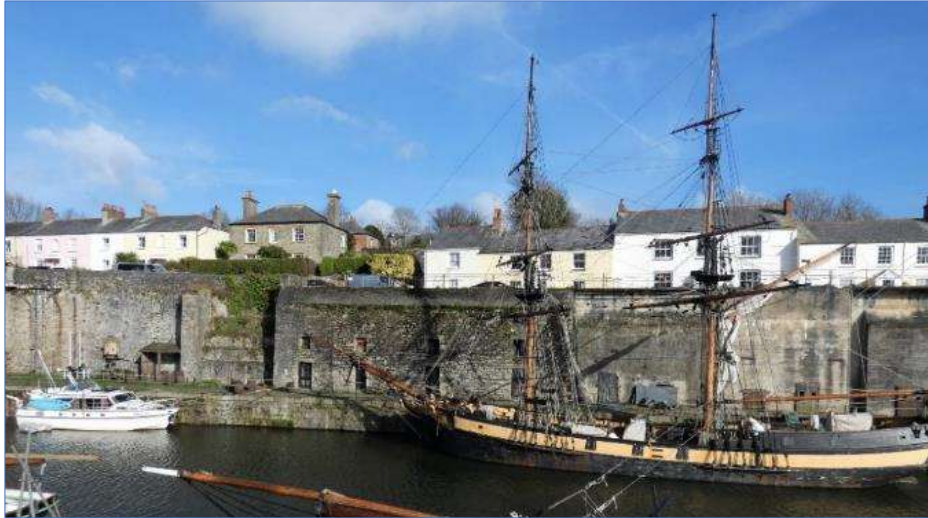
China clay loading hatches on the east side of the inner harbour.

China clay would have been loaded into the cellars from trap doors on Quay Road and collected by tram from the openings at harbour level. The earliest cellars are constructed from granite in four bays with three later reinforced concrete bays adjoining to the south. In the south east corner of the inner basin are two rubble masonry walls – all that survives from late nineteenth century ore hutches, built for the temporary storage of copper prior to shipping. The early twentieth century wide concreted arch in the north eastern corner of the inner basin connects the Lovering china clay dry to the harbour by means of a tunnel; a unique survival and important evidence of the evolving nature of the working landscape.

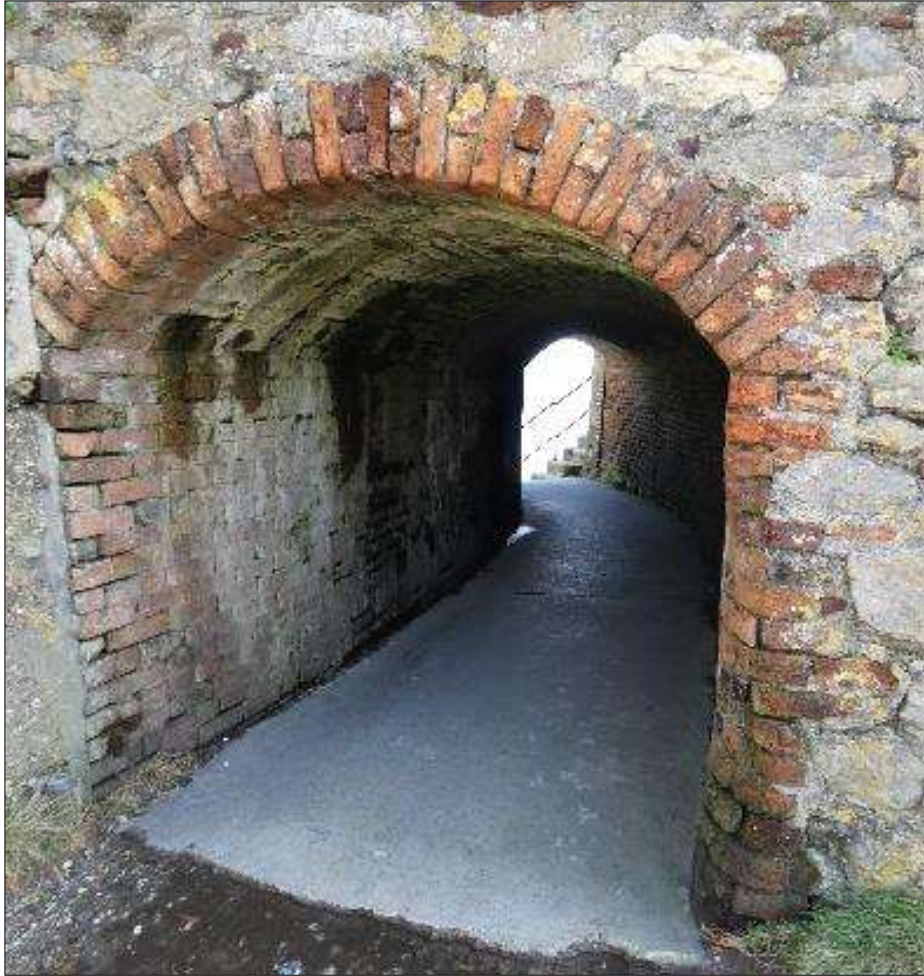
The brick-lined tunnel linking the eastern side of the inner harbour to a point above the beach.

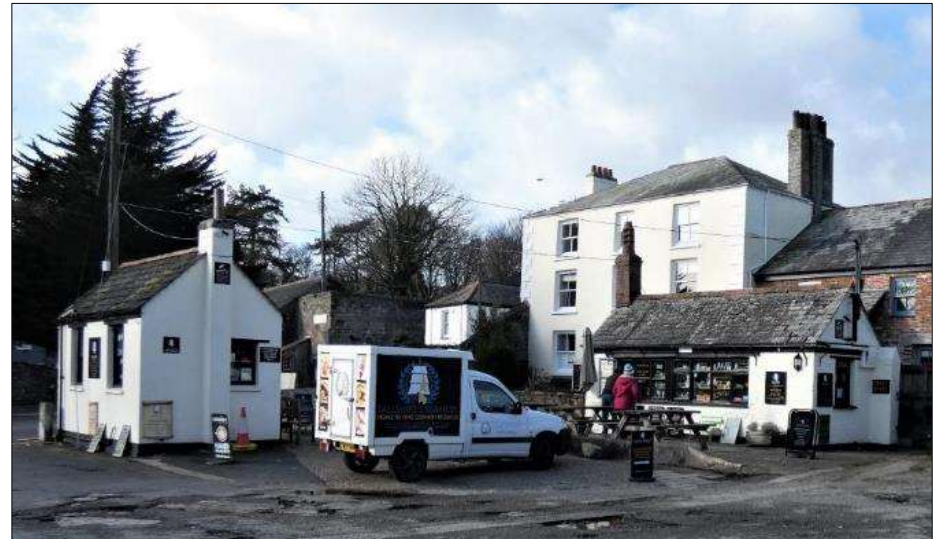
The two weighhouses with their accompanying weighbridges form an intriguing part of the harbour's story, although they are often somewhat obscured by modern commercial activity.

Two good examples of weighbridge buildings form part of the complex. These simple single-storey buildings feature multi-paned windows, single brick chimneys and large cast iron weighing platforms.

Weighbridges: Two weighbridges and accompanying buildings are sited at the head of the harbour and were formerly a key element in the administration of trade through the port. The 'old' one was first recorded in 1882 and is a large cast iron platform manufactured by Avery of Birmingham. The 'new' weighbridge and its associated building were built in 1936. The cast weighbridge platform is marked 'To weigh 20 tons Charles Ross Ltd, Makers, Sheffield'.

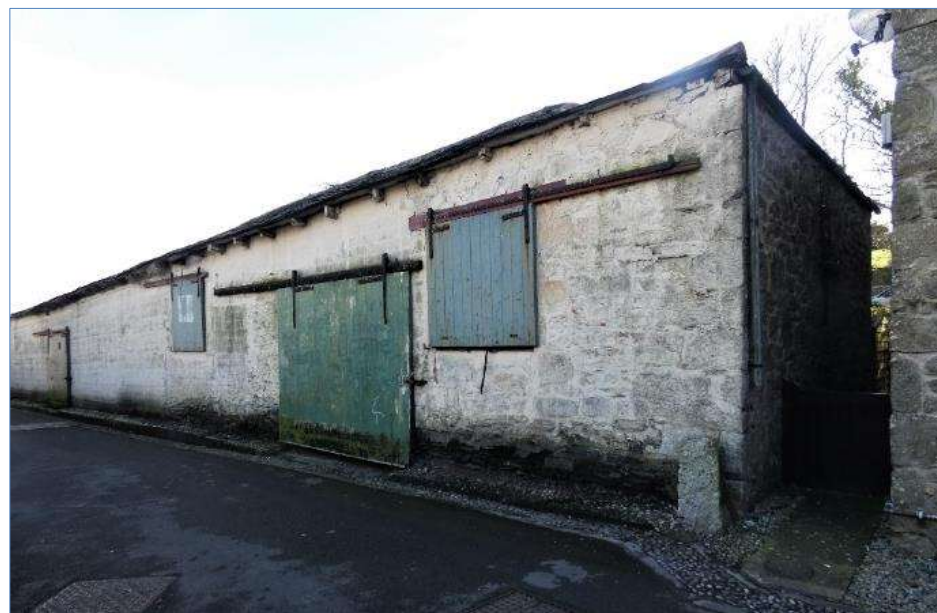
The remains of an early nineteenth-century fish cellar in Barkhouse Lane.

Fish cellars: The remains of a number of fish cellars survive. Characteristic features include rows of beam sockets used in pressing fish in wooden casks. Examples of former cellars are in Quay Road (now Salamander), on Barkhouse Lane and in Duport Road.

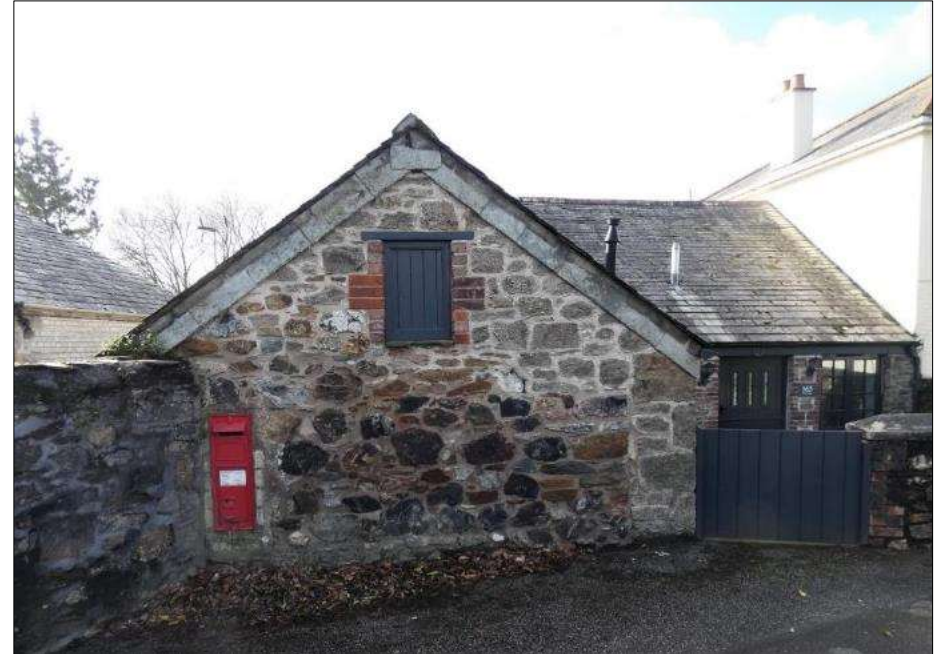
The mid-nineteenth-century former smithy at 165 Charlestown Road. Its single-storey form, irregular window arrangement and roadside location are indicative of its former use. The rare VR post box is a significant element of Charlestown's varied street furniture.

A Listed single-storey smithy survives at 165 Charlestown Road. Now converted for residential use, its L-shape plan incorporates an area for shoeing and wheelmaking at the front and a larger forge room behind.

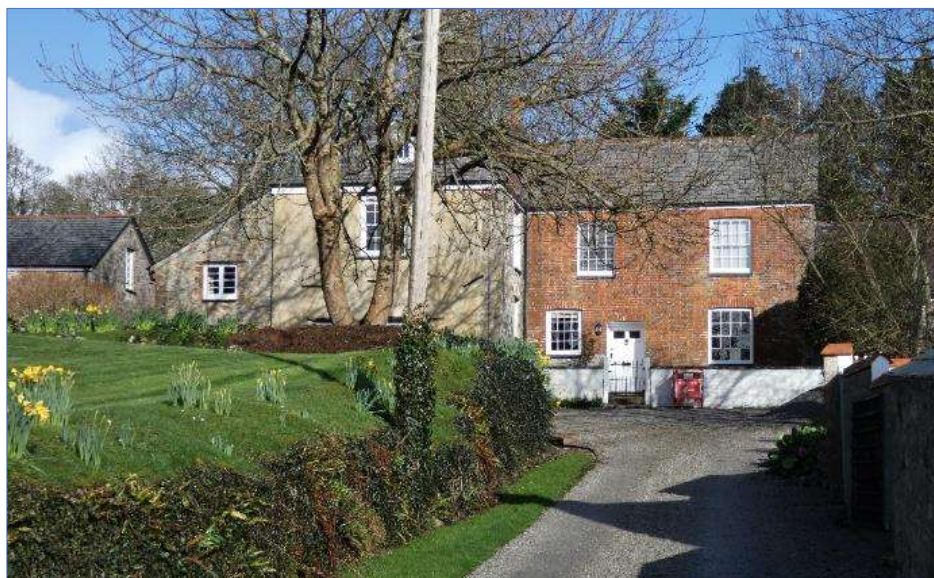
Polmear farmhouse, one of the few buildings which pre-dates the construction of Charlestown.

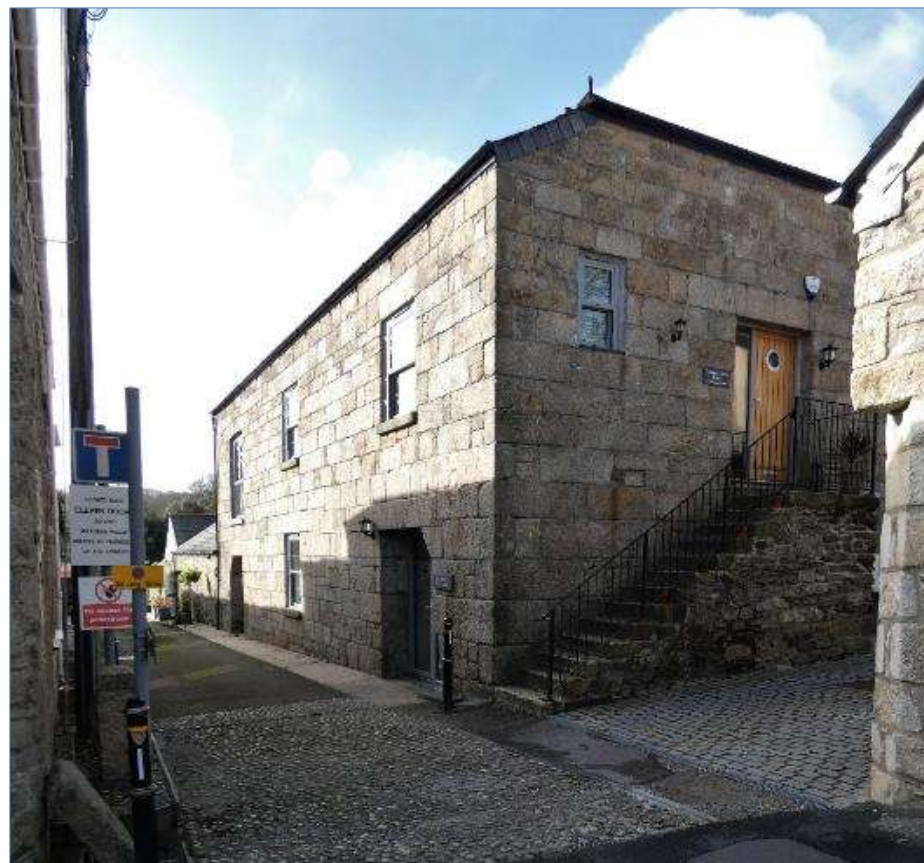
The former water-powered threshing barn, later used as a china stone mill, on the north side of Eleven Doors. It is constructed from finely dressed moorstone granite.

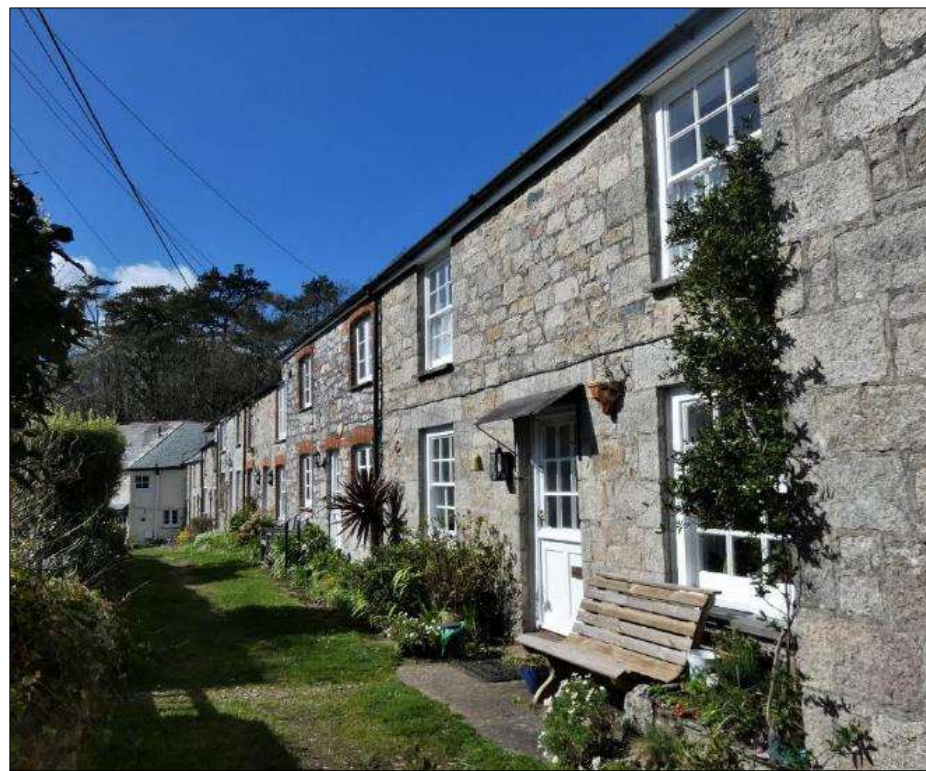
The southern elevations of the Grade II Listed former back-to-back dwellings at 51-63 Charlestown Road.

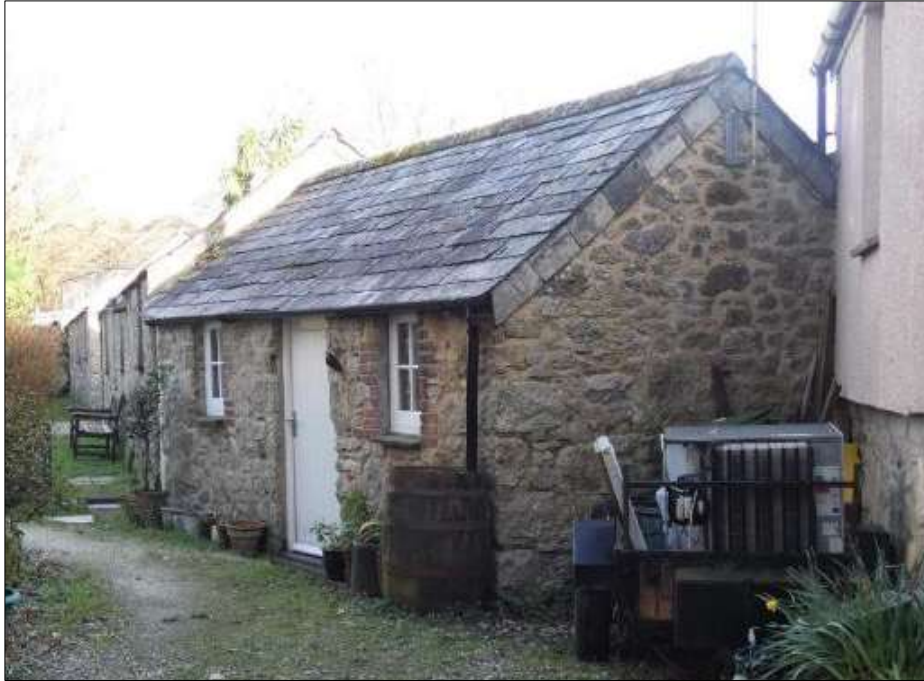
Significant numbers of outhouses, including washhouses and privies, survive in Charlestown and are an important record of former living conditions.

The high level of survival of outbuildings and other ancillary structures is a particularly notable feature of the village and gives a completeness and sense of past domesticity to the townscape. Wash houses, privies, earth closets, coal houses and similar buildings form this unusual group and survive due to the low levels of change that have occurred in Charlestown by comparison with other Cornish settlements.

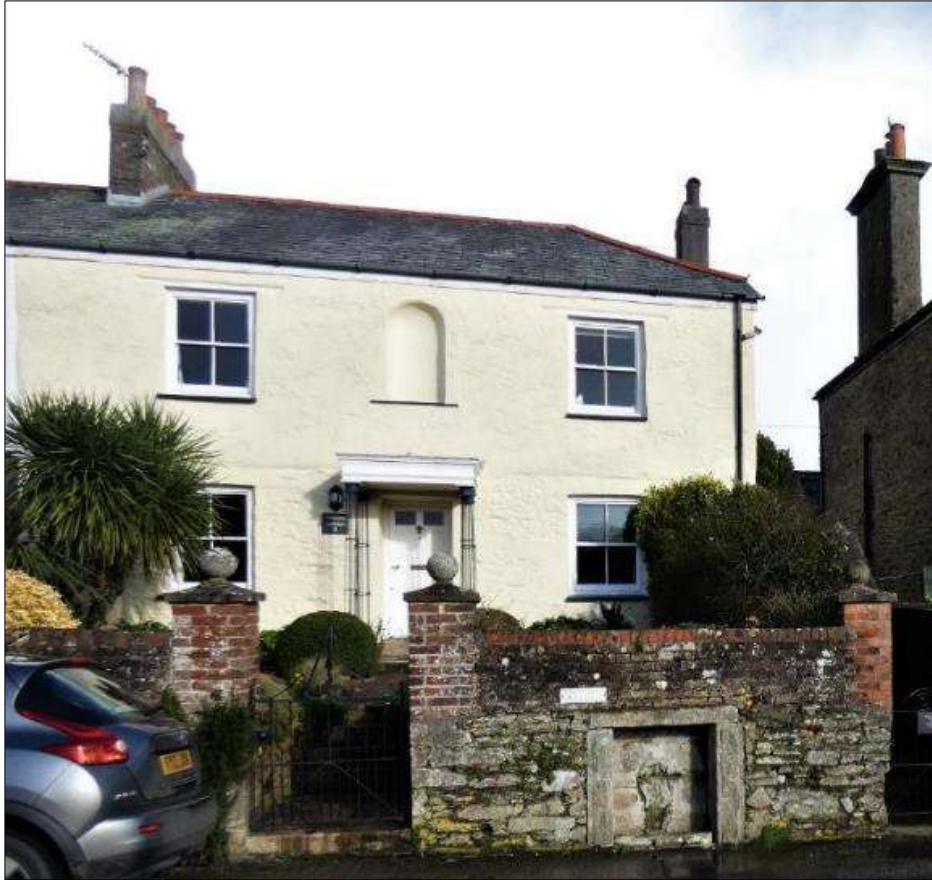
A Classical niche above the doorway on 12 Quay Road, with a porch with iron supports and a dressed granite water supply structure in the multi-phase front boundary wall.

Dressed granite niches: These simple but significant structures are found throughout the village and were built to house communal water taps serving particular groups of dwellings.

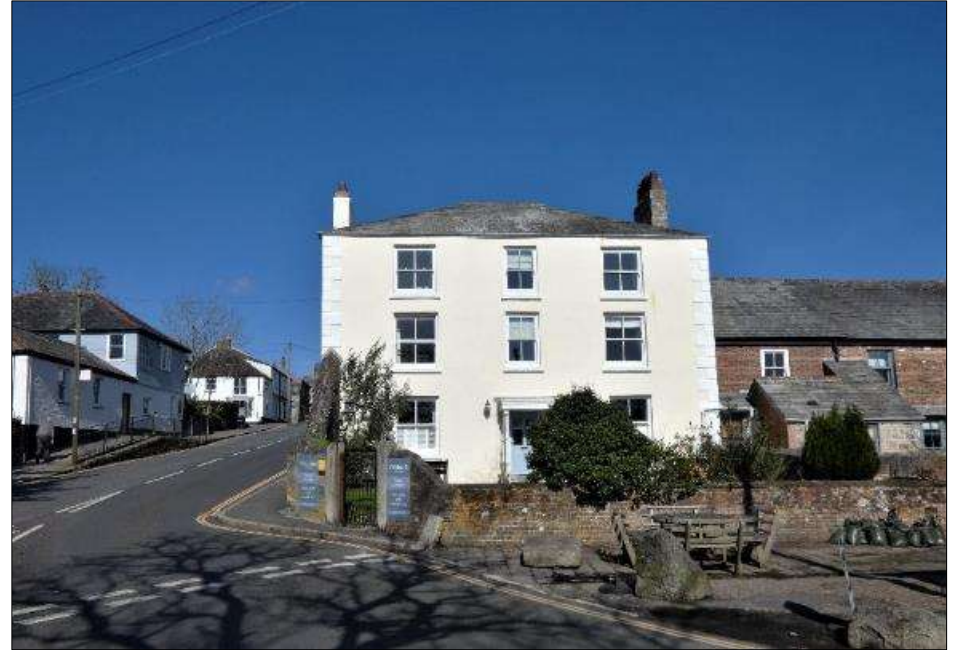
Classical proportions and detailing on the façade of no 6 Charlestown Road (now known as T'gallants).

Larger private residences include 6 Charlestown Road (currently known as *T'Gallants*), the former coastguard station. This is a three-storey, three window wide, symmetrically fronted stuccoed property with central door and porch detail. It directly addresses the inner basin and encloses the harbour area to the north. *The Beeches*, 60 Charlestown Road, formerly *The Villa*, is a large property set in private grounds.

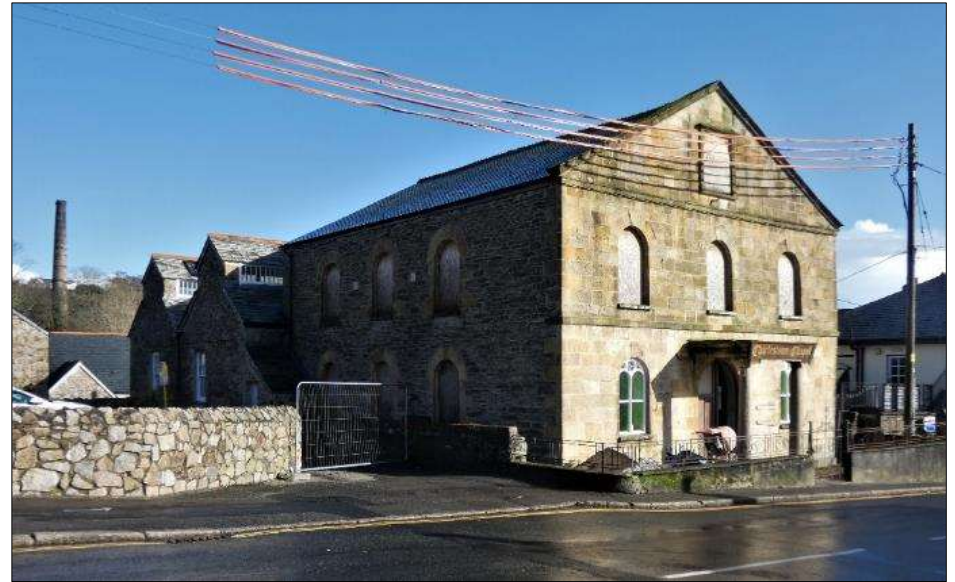
The early nineteenth-century Charlestown Wesleyan Methodist chapel with its later Sunday School extension to the rear is a key building in the streetscape.

The Grade II* Listed **Wesleyan Methodist Chapel**, like many nonconformist chapels, takes the form of a tall box-like structure with a Classical façade. Attached at the rear is a substantial schoolroom extension with unusual clerestory roofs. It was one of the earliest galleried chapels in Cornwall and the later interior (possibly by Cornish architect Silvanus Trevail) had a high level of completeness. However, it has undergone extensive refurbishment for residential and commercial (class A) use and the interior has been significantly altered.

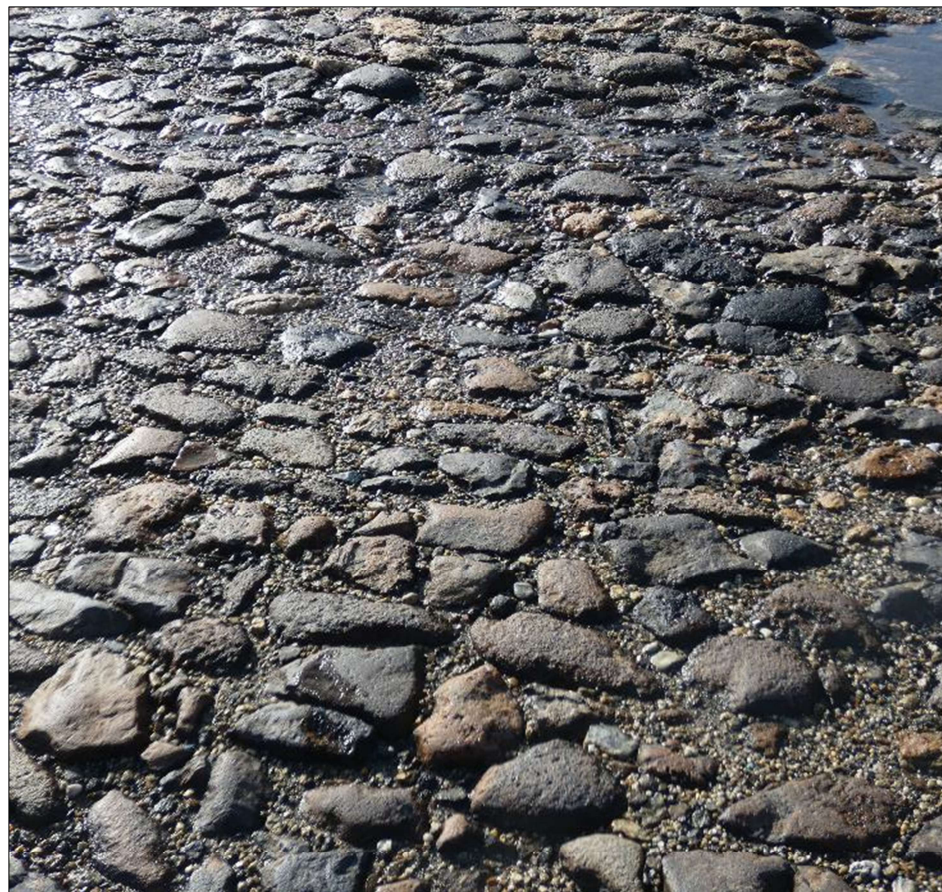
The distinctive surfacing of the former ore floor now used as the Rashleigh Arms car park.

Ore floors: Surviving examples of these historic cobbled surfaces, formerly used for storing copper ore and china stone prior to shipment and for coal brought into the port, can be found at the Rashleigh car park, the main car park and the old cooperage / coal yard. Some of the historic yards have surviving surrounding walls.

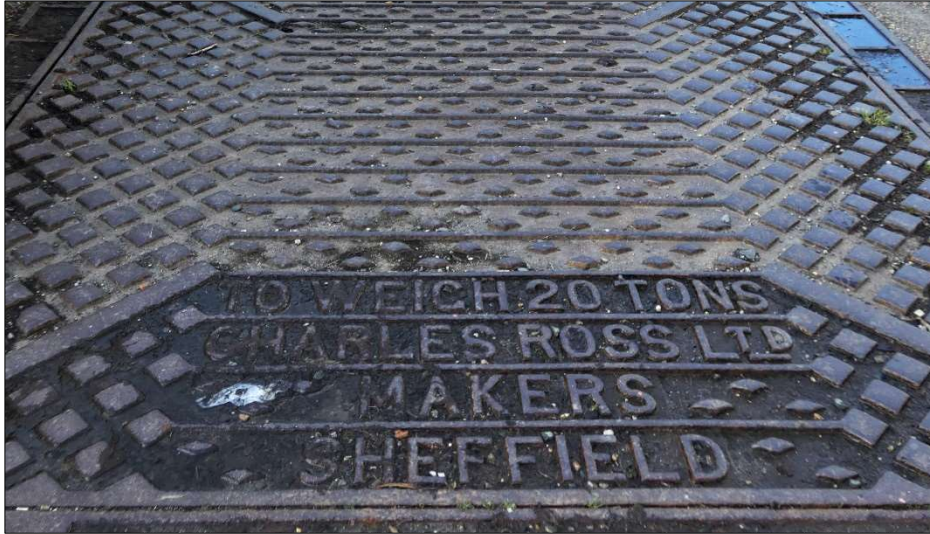
The maker's details on the 'new' weighbridge.

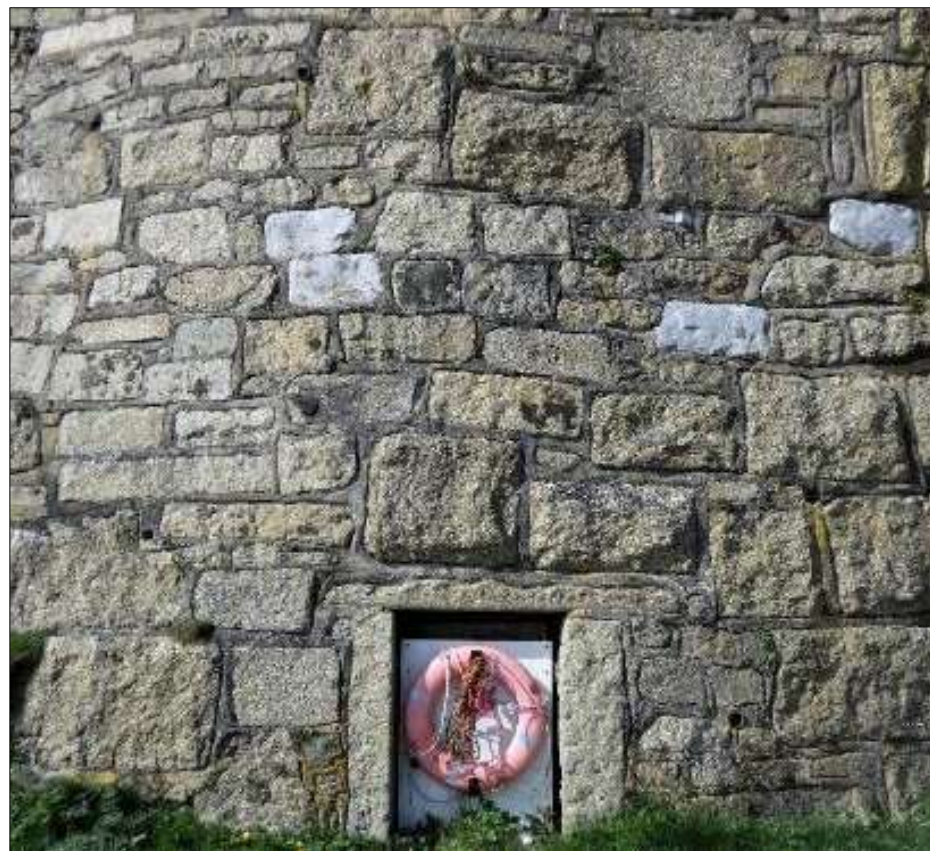
Massive moorstone (granite) blocks face the retaining wall to the west of the outer harbour.
