Charlestown Conservation Area Character Appraisal and Management Plan

2020

The document was commissioned by St Austell Bay Parish Council and prepared by Cornwall Archaeological Unit, Cornwall Council.

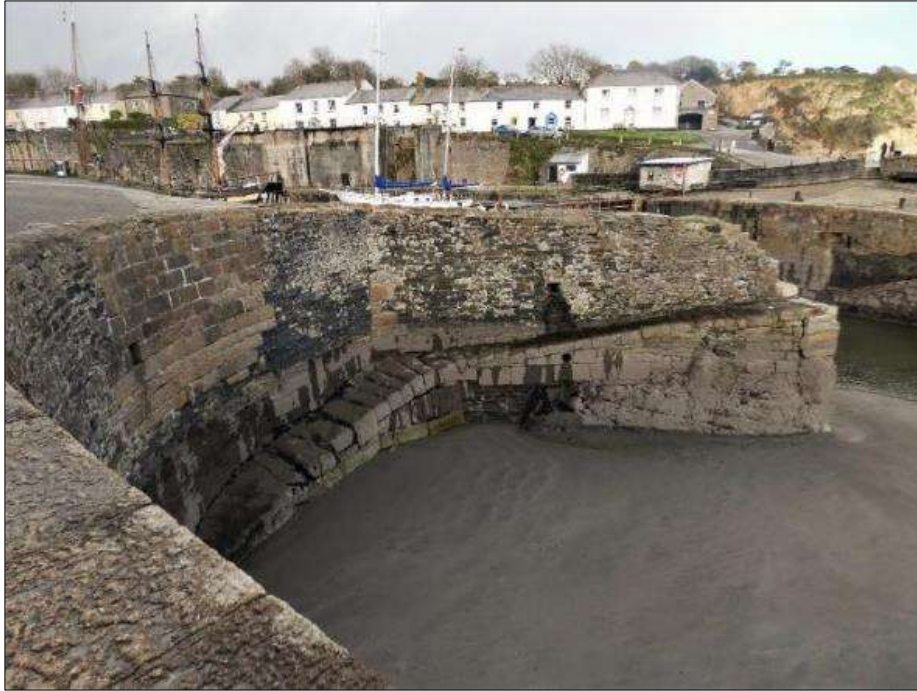
The sandy tones of the moorstone blocks which form the complex stonework of the harbour walls are an important element of their architectural character.

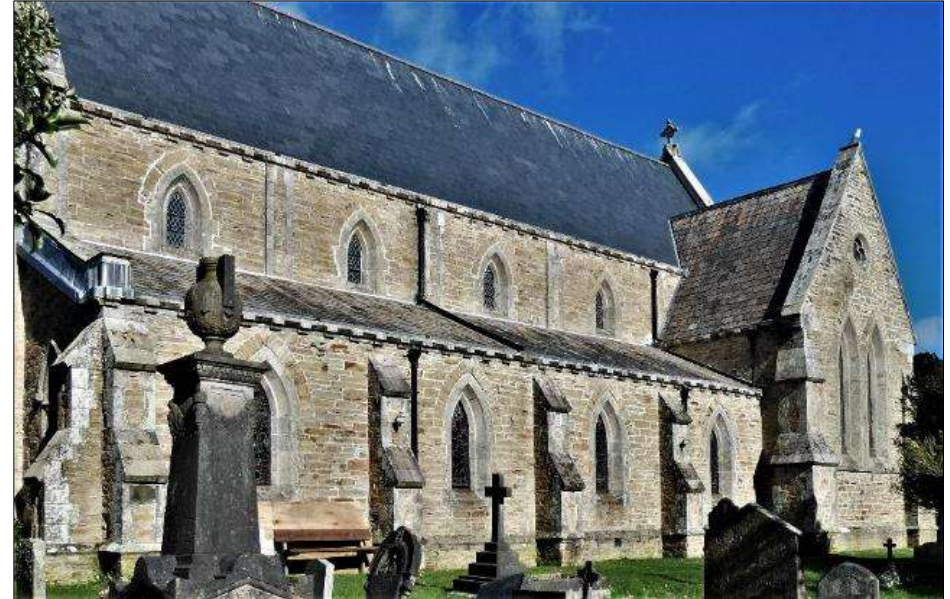
Semi-coursed dressed killas with granite dressings used for the main body of St Paul's church.

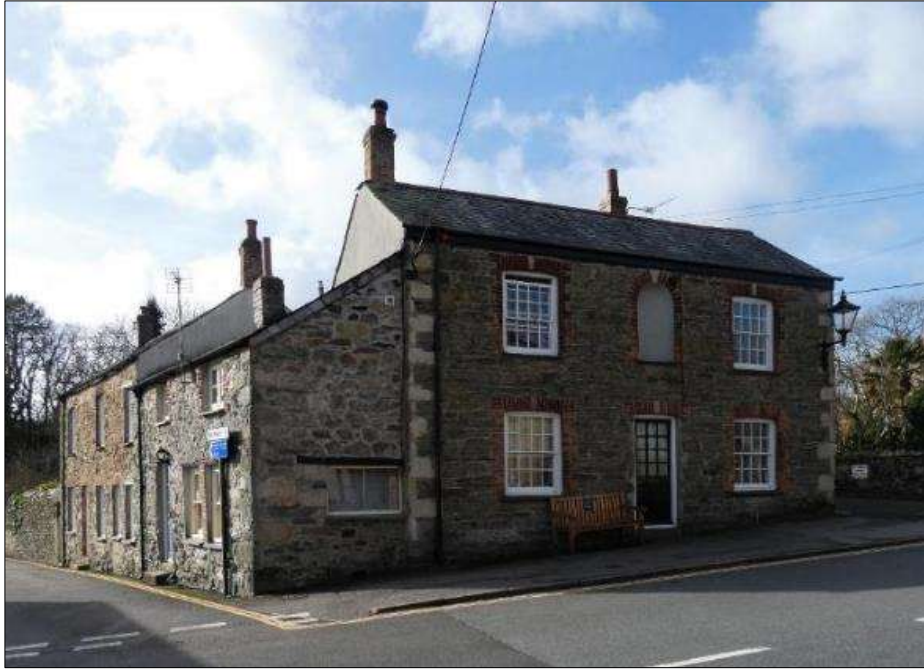
Killas, moorstone and brick in a group of houses on the corner of Charlestown Road and Duporth Road, a mix typical of many of the nineteenth-century buildings in Charlestown.

Red brick is used extensively for dressings and chimneys in structures otherwise in killas or moorstone and is incorporated into the façades of the Old Granary and Polmear farmhouse. There are several other structures predominantly of brick, including the former count house and the shop and adjoining office on the southern corner of Charlestown Road with Duporth Road; on both these buildings the brick is painted.

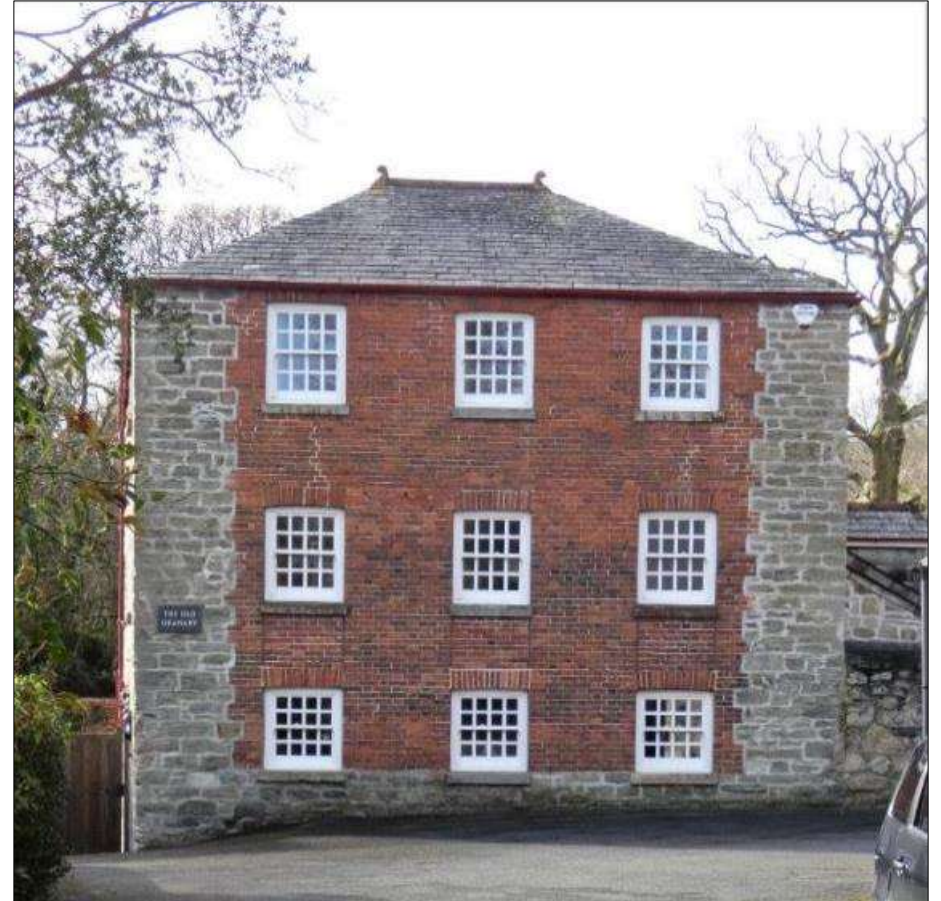
The striking red brick and granite east-facing elevation, eight-over-eight sash windows and hipped roof mark out the granary in the former farm complex on the west side of Charlestown Road as a building of some status.

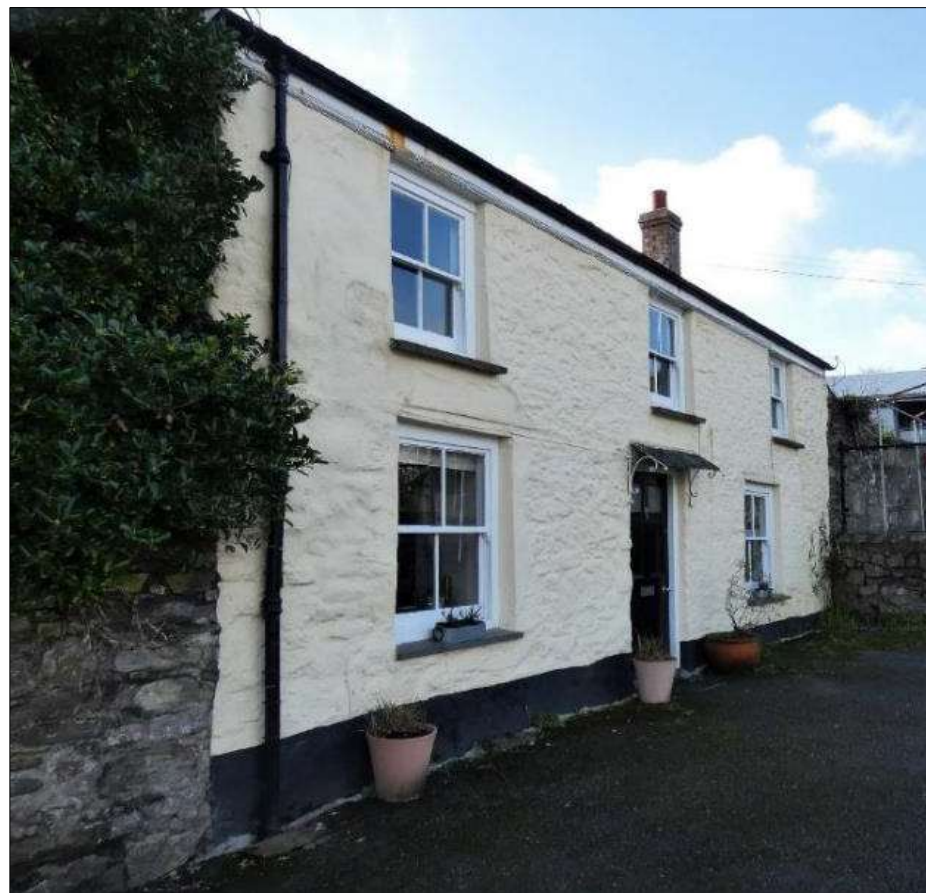
21 Charlestown Road, an eighteenth-century cottage recorded as of rubble and cob construction. It is likely to pre-date construction of the adjacent harbour complex.

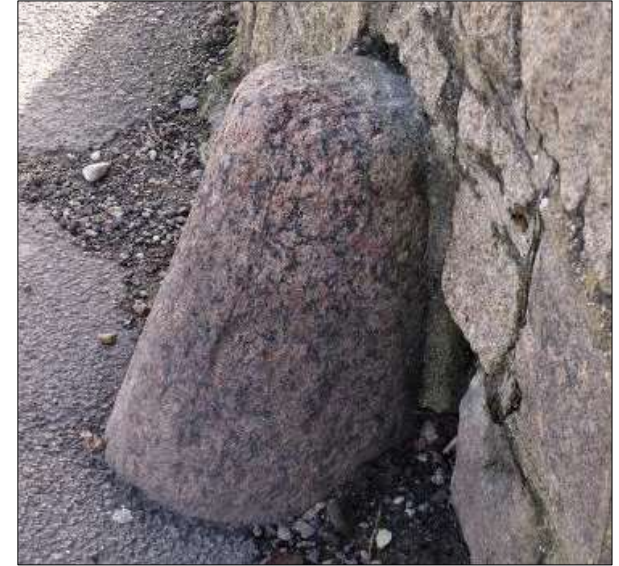
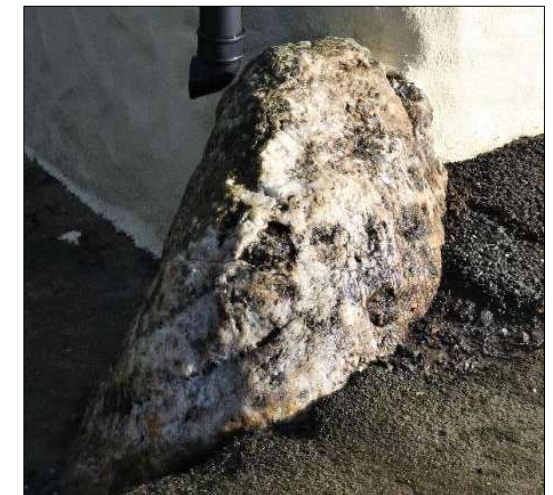
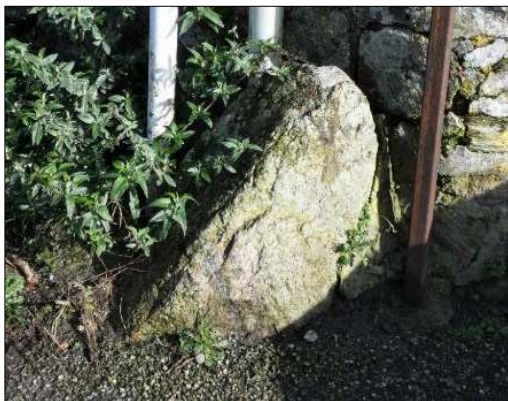
Three of Charlestown's distinctive glinter stones.

The fortunate survival of a number of **glinter stones** on exposed building and boundary corners in Charlestown emphasises the former importance of horse-drawn vehicles in carrying materials to and from the harbour and to the industrial, storage and agricultural premises within the settlement.

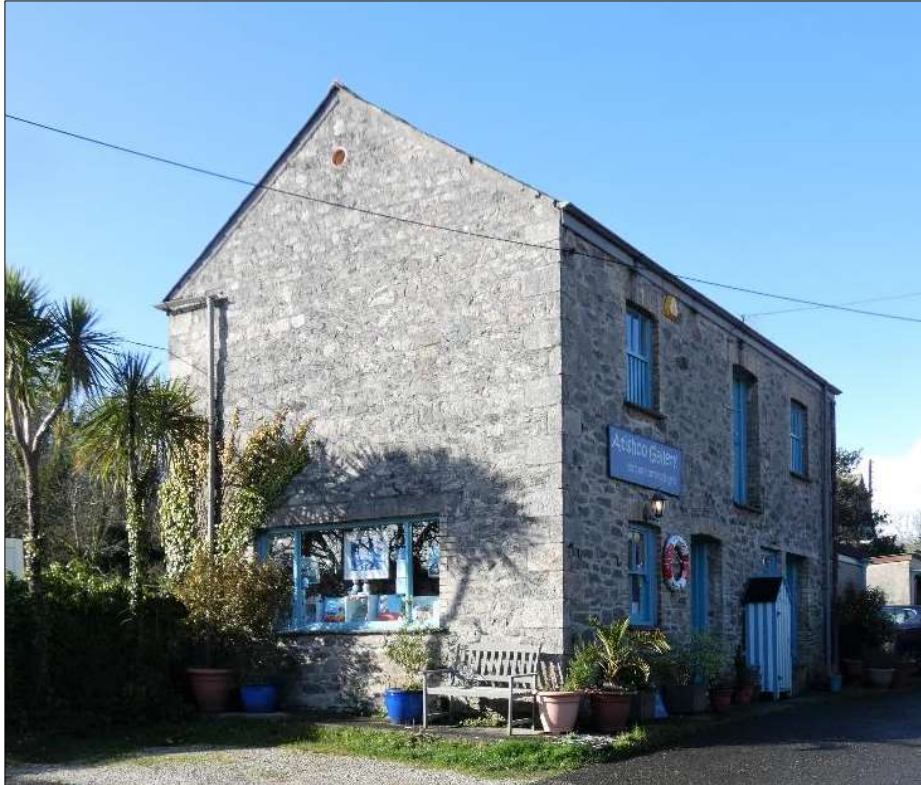
71 Charlestown Road: a former warehouse, store or possibly stable, dating to the late nineteenth or early twentieth century.

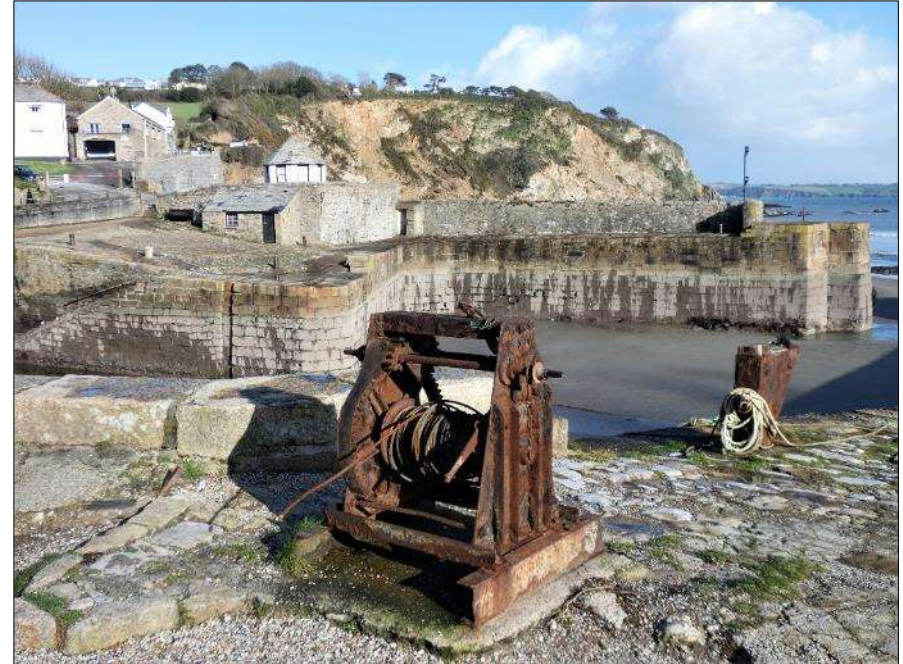
Remains of equipment from the harbour's working past are important as clues to how it formerly functioned.

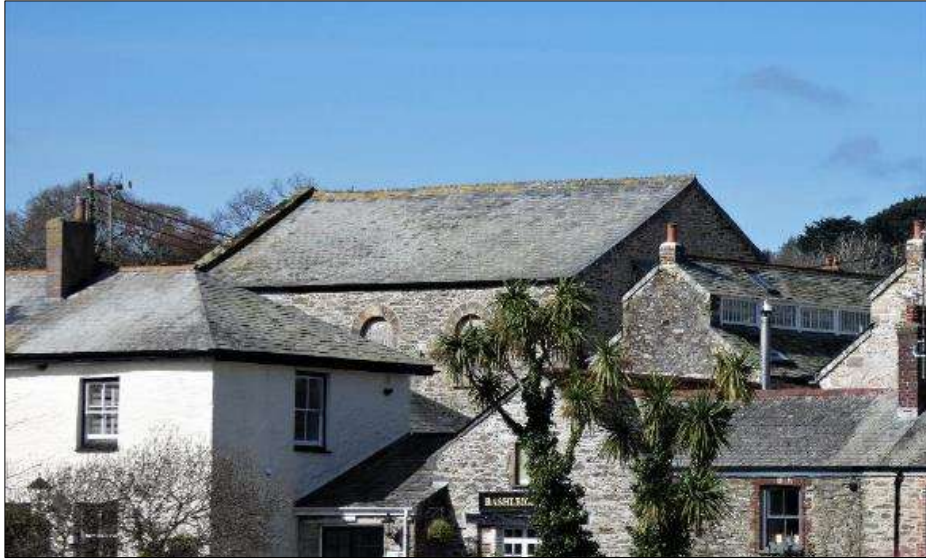
Hipped, gabled and clerestory slate roofs on the Rashleigh Arms and adjoining cottages, the Wesleyan Methodist chapel and former Sunday Schools.

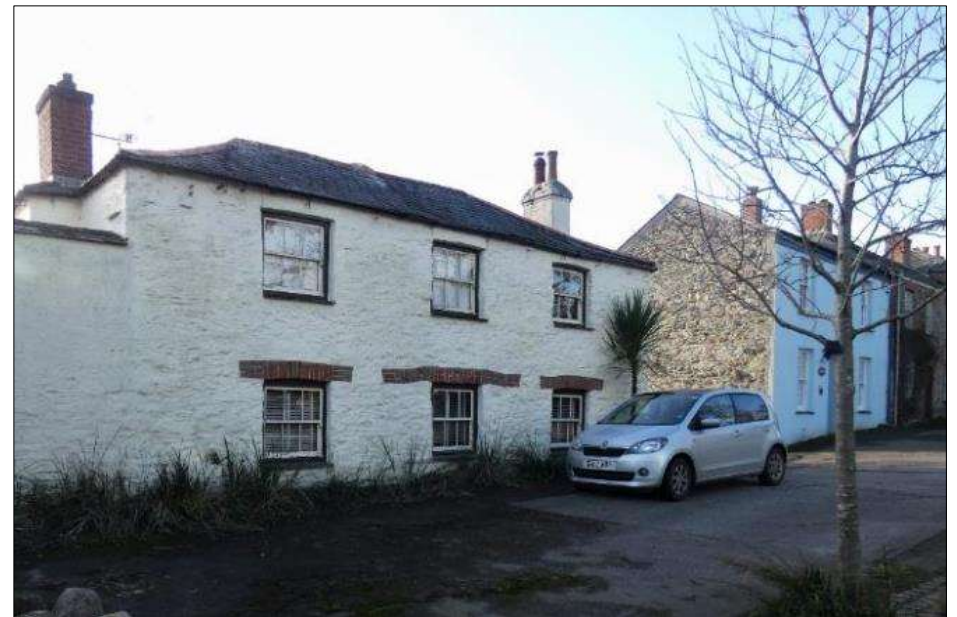
Late nineteenth-century horned six-pane sash windows on an early nineteenth-century house at 99 Charlestown Road.

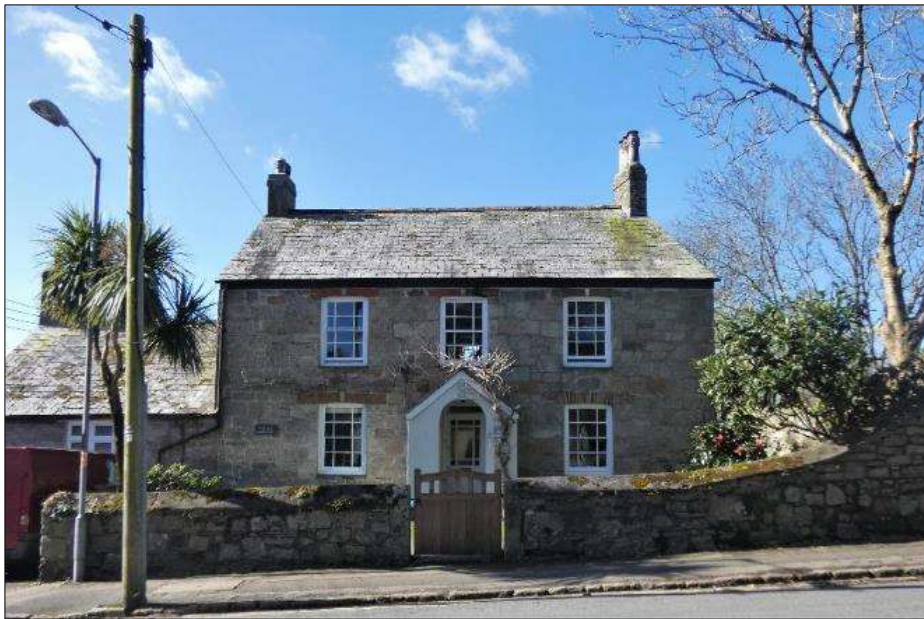
Distinctive window bar arrangements can be found on many sash windows.

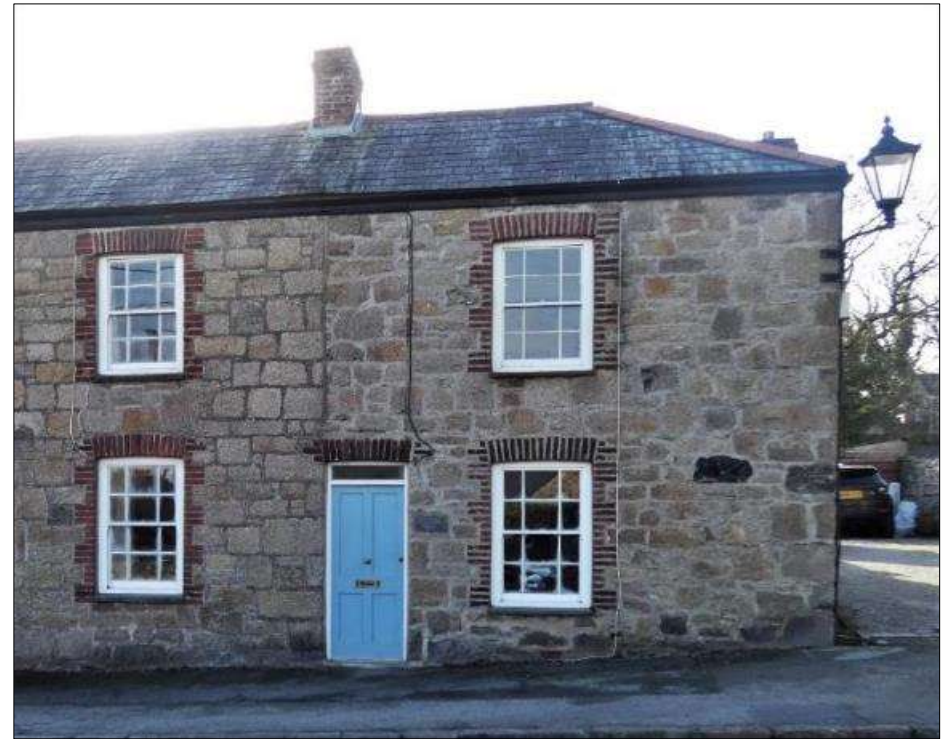
Windowsills are common and are generally of painted stone or slate.

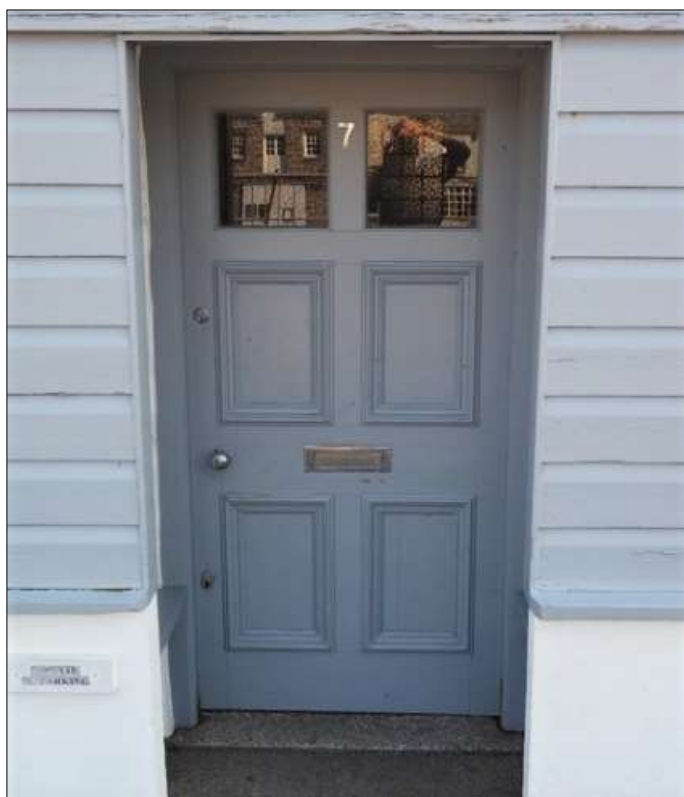
Fielded panelled front door on Quay Road.

Some industrial and former working buildings retain their original doors of simple braced plank construction. Domestic door types include solid panel doors with simple oblong lights above and half glazed panel doors. Several houses at 12–17 Quay Road have fielded panelled doors of a type generally common in the eighteenth century, but here dating from the second quarter of the nineteenth century.

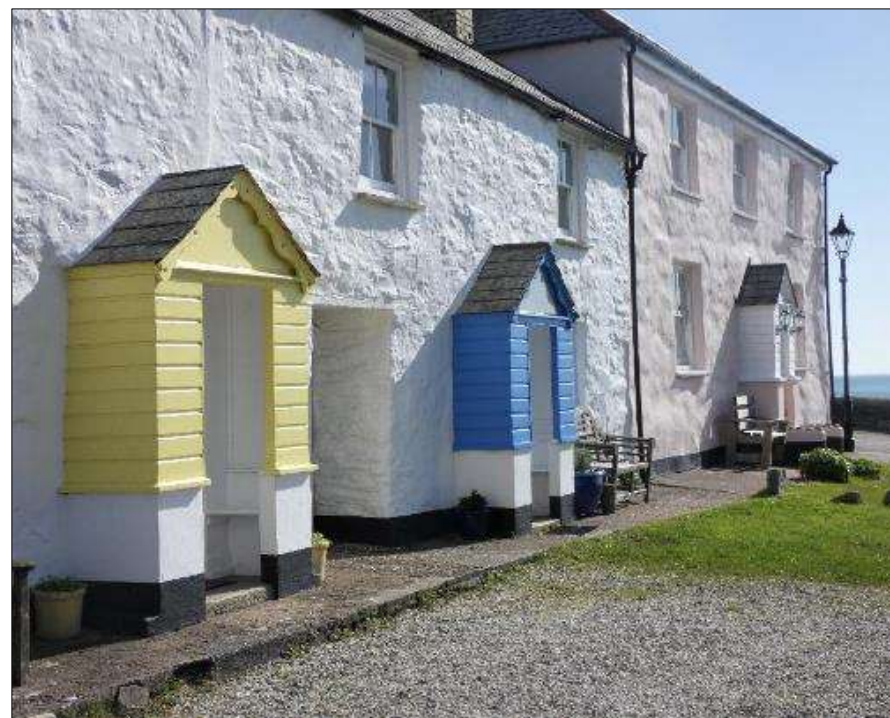
Distinctive gabled wooden porches on Quay Road.

Porches are a distinctive local detail of the village. Gabled timber storm porches are a unifying feature of the exposed properties around the harbour and close to the sea. The shiplap gabled porches of Quay Road with their decorative bargeboards are a particular feature of the iconic harbour views. Some inland properties have more architecturally elaborate arrangements,

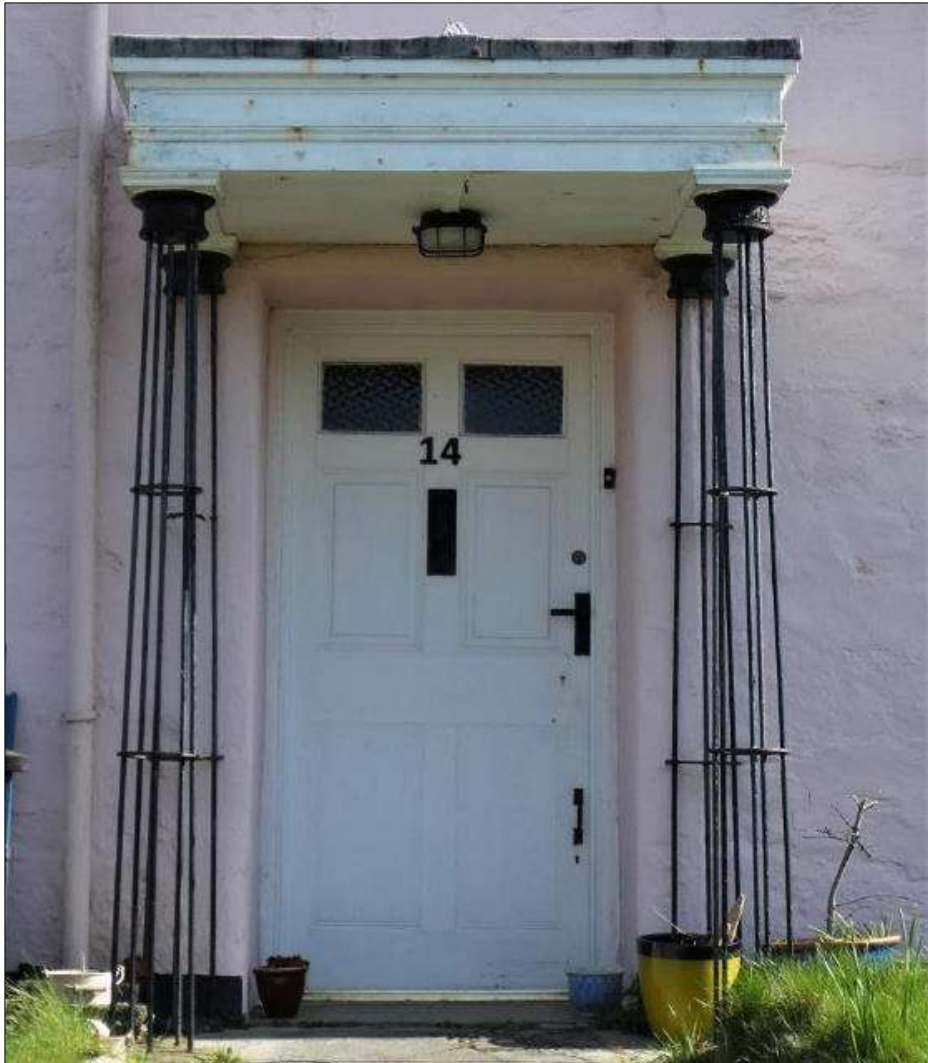
Wrought-iron columns supporting porch canopies are a distinctive element on several Charlestown houses and were probably manufactured in the village.

including a group of more ornate flat roofed porches supported on delicate wrought iron columns. This distinctive pattern is found on a number of properties throughout the village and these items were probably manufactured locally, perhaps at the foundry or smithy. Others feature stone and timber columns and pilasters, such as the Doric columns of the Rashleigh Arms' doorway and the flat porch hood with framing pilasters at 10 Quay Road.

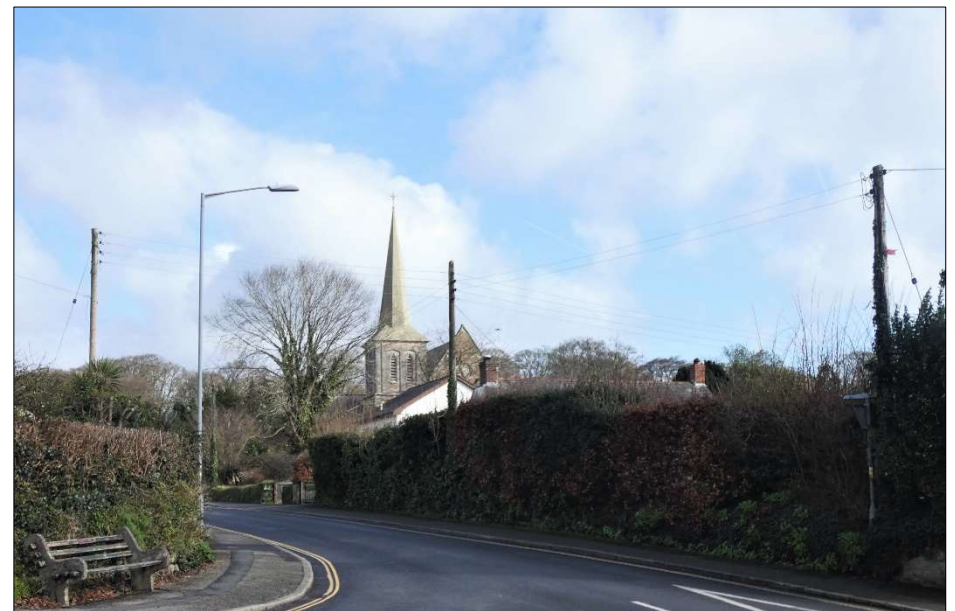
Church Road at the junction with Charlestown Road. Inappropriate lighting, electricity supply posts and overhead cabling are obtrusive.

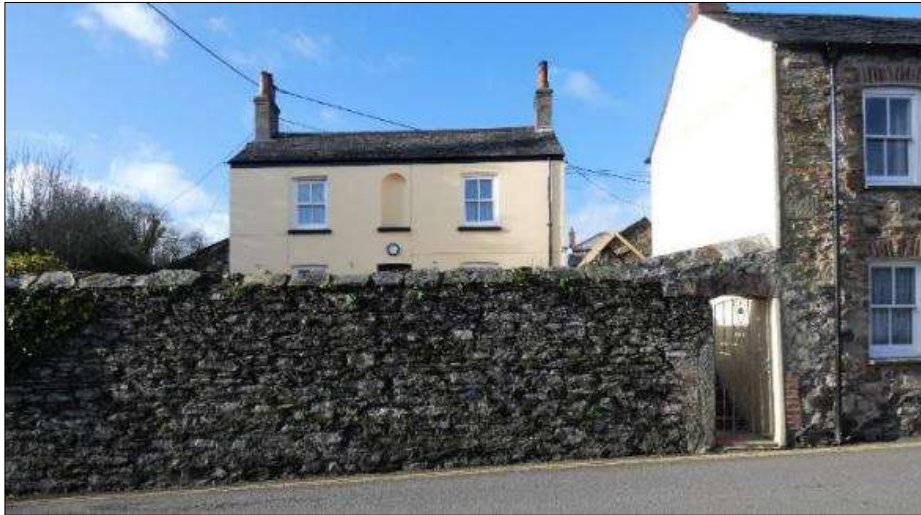
Boundary walls constructed of moorstone granite or killas are a key element in the character of the village.

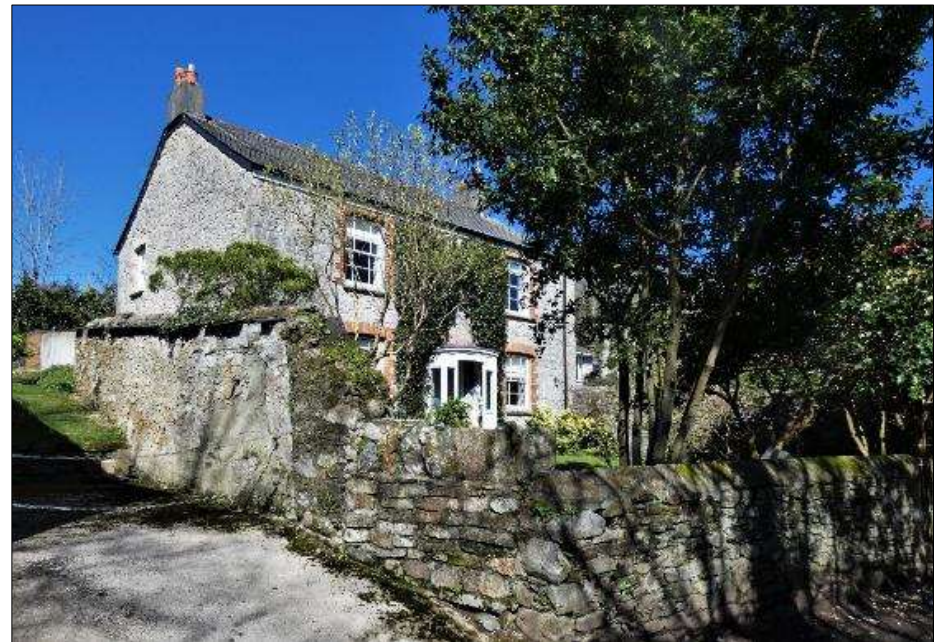
House with moorstone and killas wall to the front and an unusual survival of a cob wall with slate coping to the side.

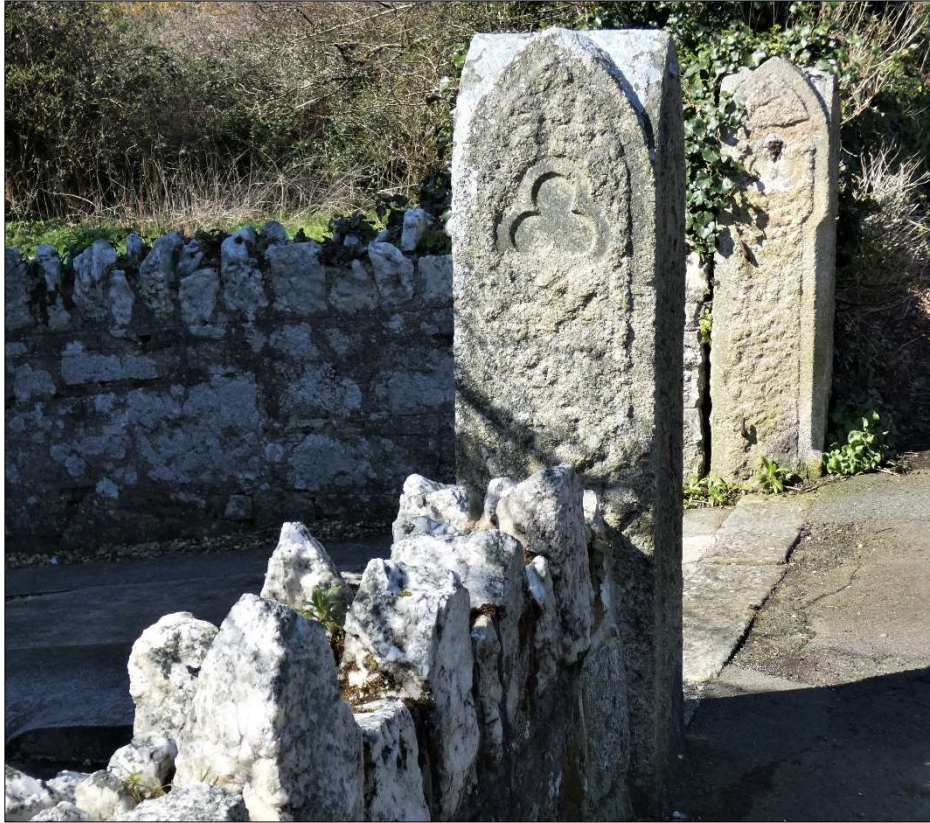
Distinctive decorated granite gateposts and spar (quartz) crenellated capping on a boundary wall fronting The Nook (formerly Ardenconnell) in Charlestown Road.

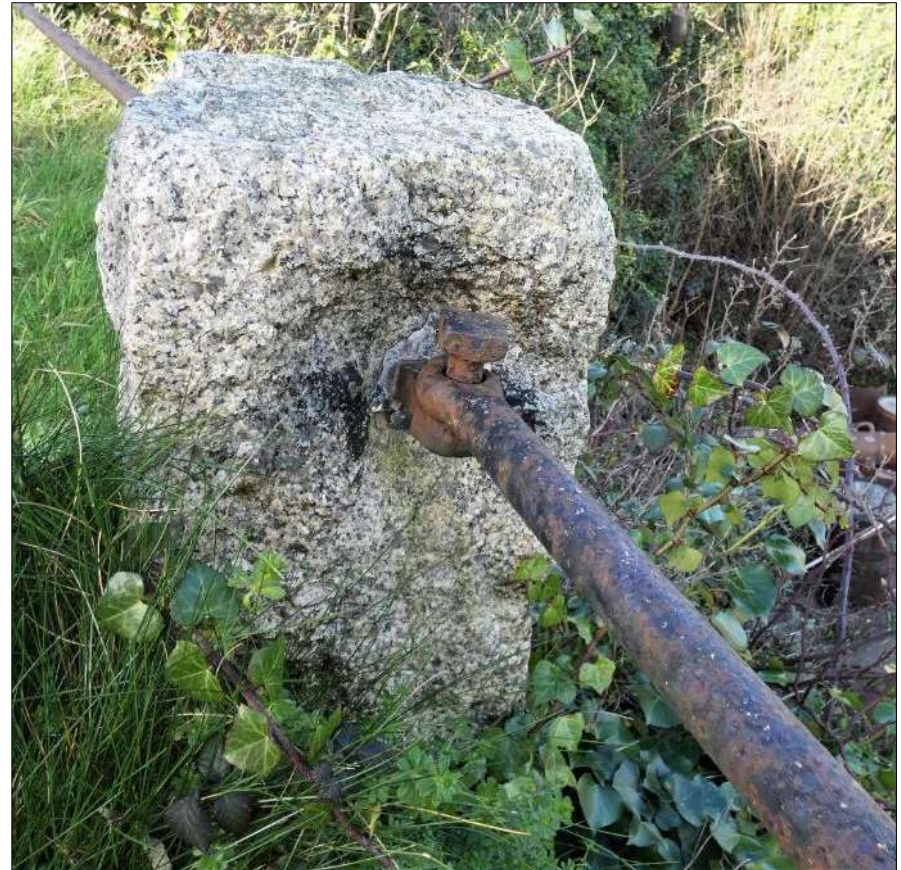
Granite posts and iron rails around the harbour reflect local materials and techniques.

Iron railings and granite posts with iron rails: The use of iron railings may reflect the former presence of the foundry. Many were removed as a contribution to the war effort in World War Two. Some of the safety railings around the harbour have an unusual design of iron pintails leaded into split granite posts; others appear to be of hexagonal section, as are some on the coast path to the battery. Lengths of tramway rail are used as uprights on the railings bordering the leat in Duporth Road. Examples of distinctive, simple but decorative wrought iron gates in the village also reflect its important ironworking tradition.

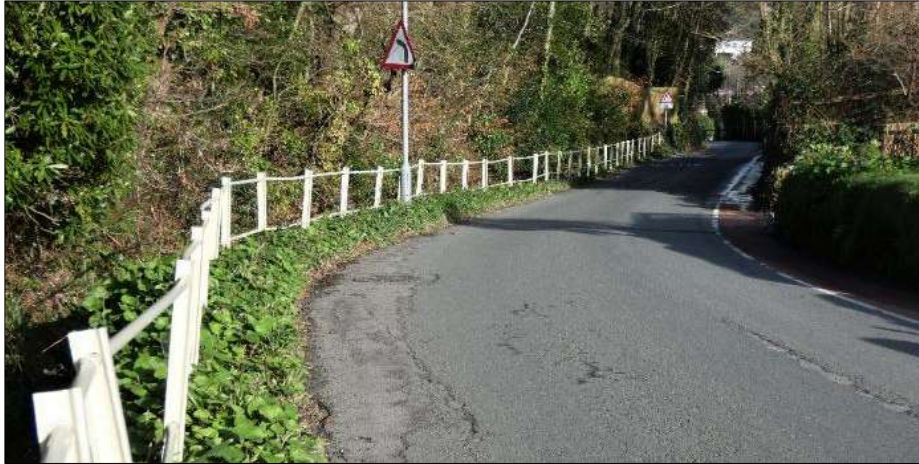
Railings along Duporth Road; the uprights are lengths of former tramway track. The earthwork embankment to the left encloses the Lower Pond.

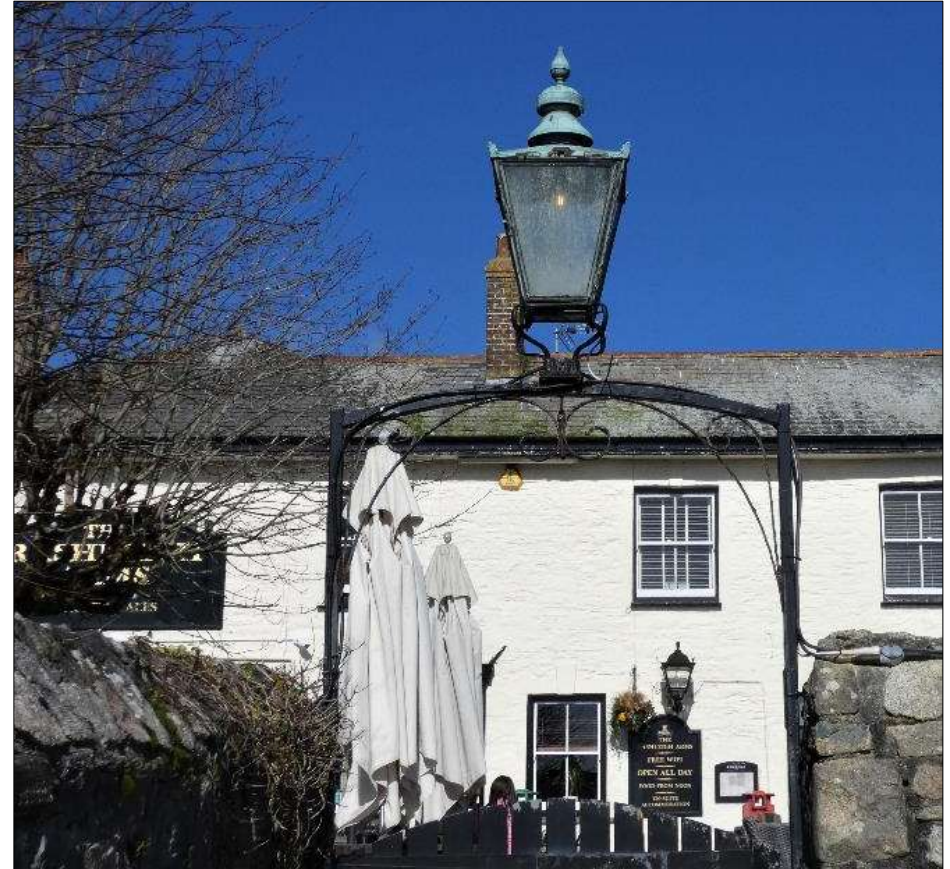
The lantern and decorative overthrow outside the Rashleigh Arms reflect the village's important ironwork tradition.

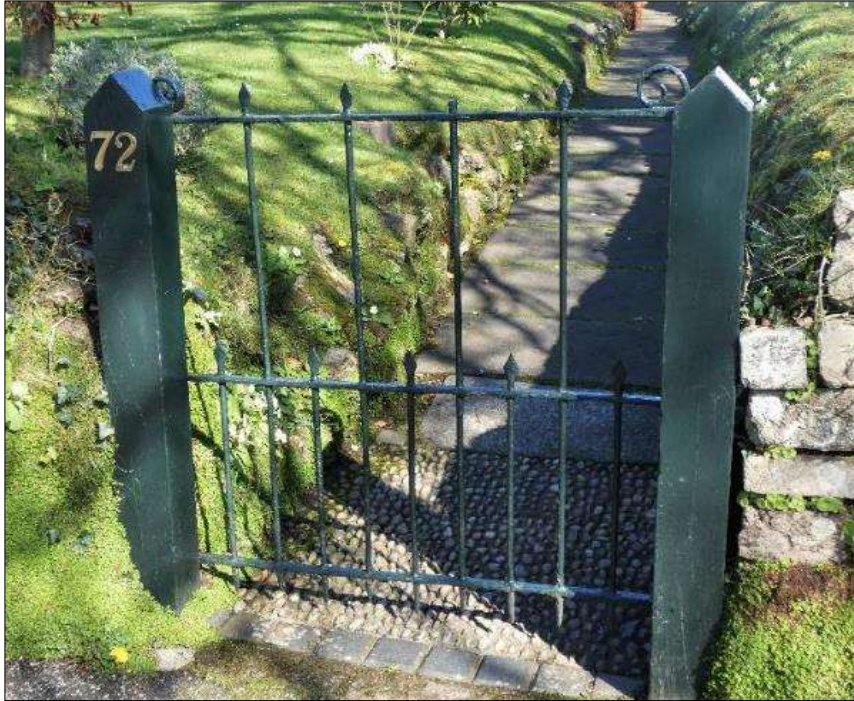
Examples of wrought iron gates, possibly manufactured locally, can be found in various places around the village.

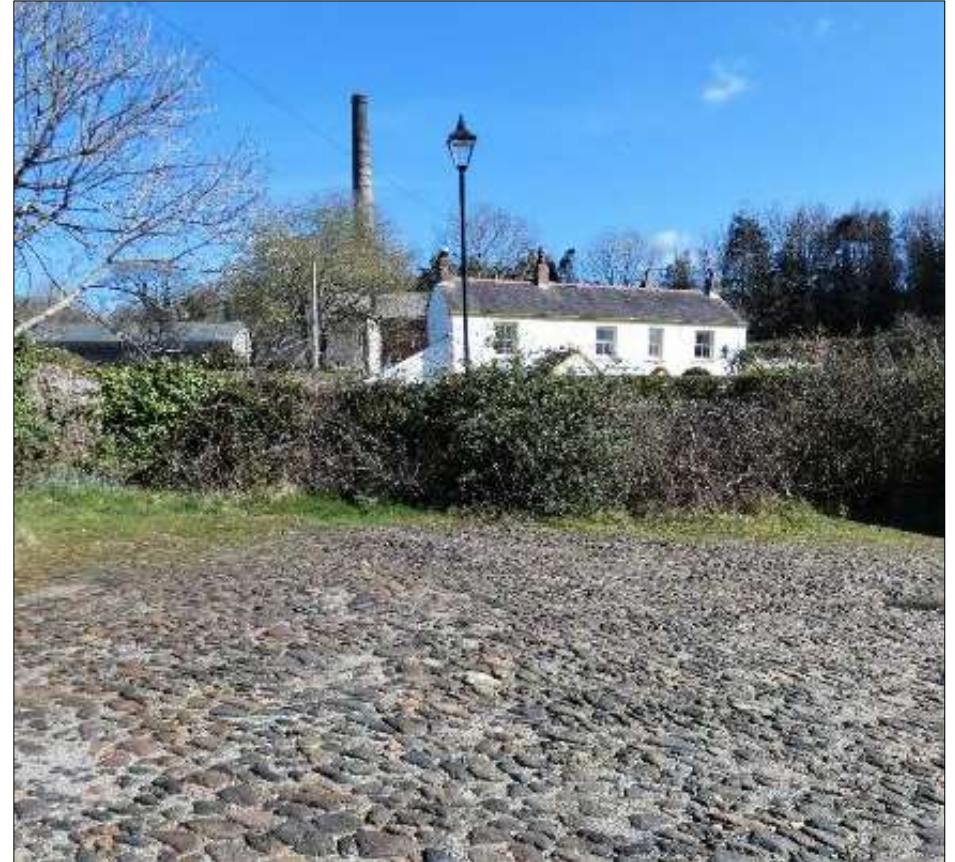
The stone incorporated in the colourful surface of the former ore floor now used as the Rashleigh Arms' car park is said to have been constructed from material brought into the port as ballast.

Ore floors: Surviving examples of these historic cobbled surfaces, formerly used for storing copper ore and china stone prior to shipment and for coal brought into the port, can be found at the Rashleigh car park, the main car park and the old cooperage / coal yard. Some of the historic yards have surviving surrounding walls.

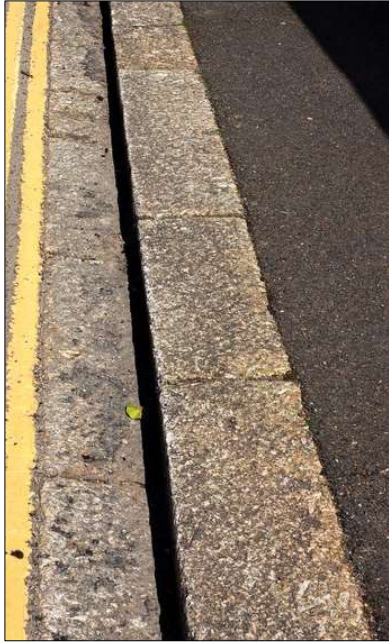
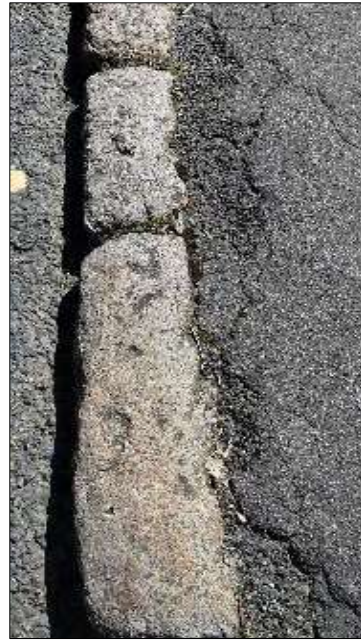
Left: wide granite kerbs and gutters. Right: narrow, roughly dressed moorstone kerbs.

the southern side of Charlestown Road in front of nos 45–63 and around the corner into Duporth Road the pavement has wide granite kerbs adjacent to cobbled gutters.

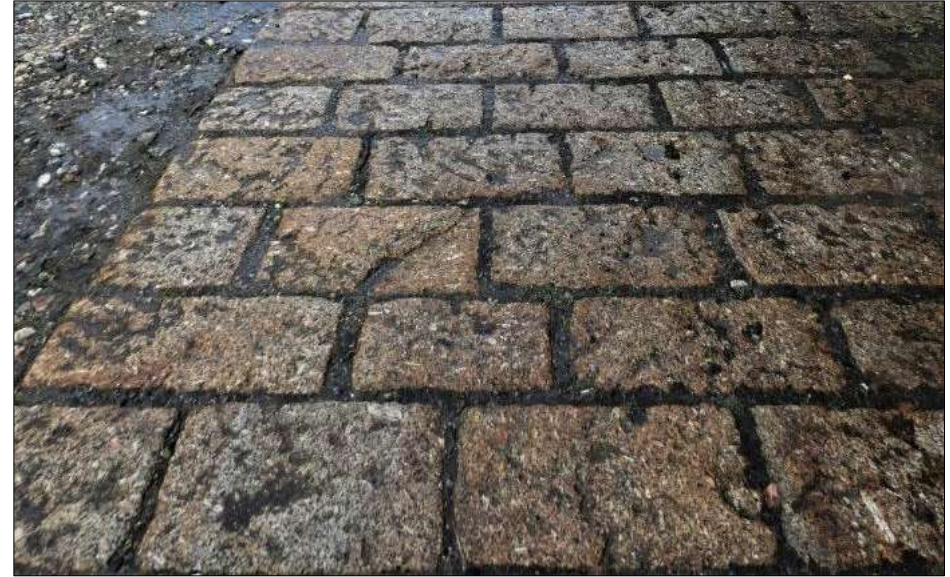
Surfacing of roughly dressed squared moorstone slabs adjacent to the former china clay cellar near the harbour (now the Shipwreck Treasure Museum).

The harbour and quayside areas are partly paved in squared moorstone slabs and granite blocks; in other areas surfacing is of water-rounded stones set in a mortar matrix. Small areas of moorstone paving survive to the west of the weighbridge platform and in the area around the former china clay cellar now used as the Shipwreck Treasure Museum. Flights of granite steps and ramps lead from the quayside to the water. A small area of high-quality historic granite paving, including rounded kerb corners, is located at the south-west corner of the Rashleigh Arms.

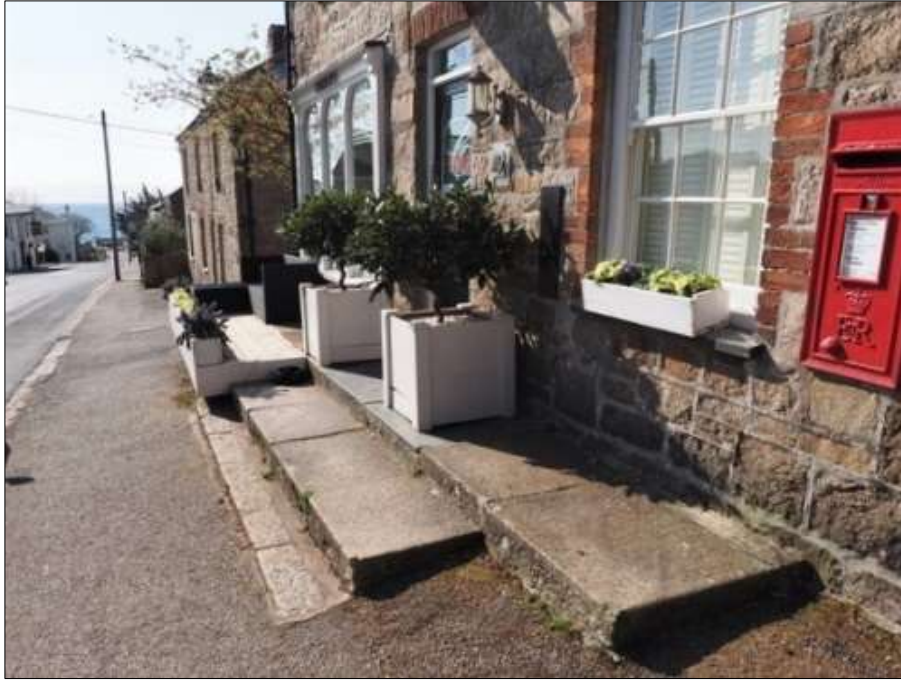
Wide granite steps fronting 79 Charlestown Road.

Granite, predominantly moorstone, is used throughout the settlement for steps and plinths where there are changes in level. The Pier House Hotel sits above Charlestown Road on a granite block plinth with a flight of wide granite steps leading to the entrance. In front of the former count house and estate office on Charlestown Road the pavement rises above the road and is fronted by granite blocks. Wide granite steps front the former post office at 79 Charlestown Road but have been partly concealed by modern decking.

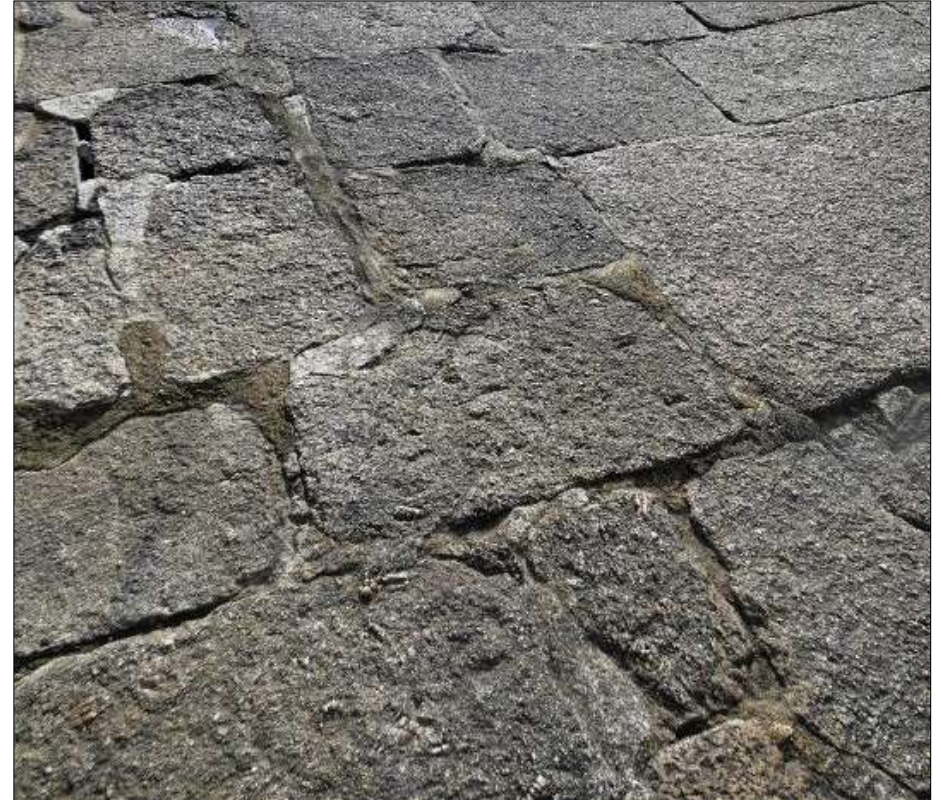
Large slabs of moorstone pave the quay alongside the outer harbour.

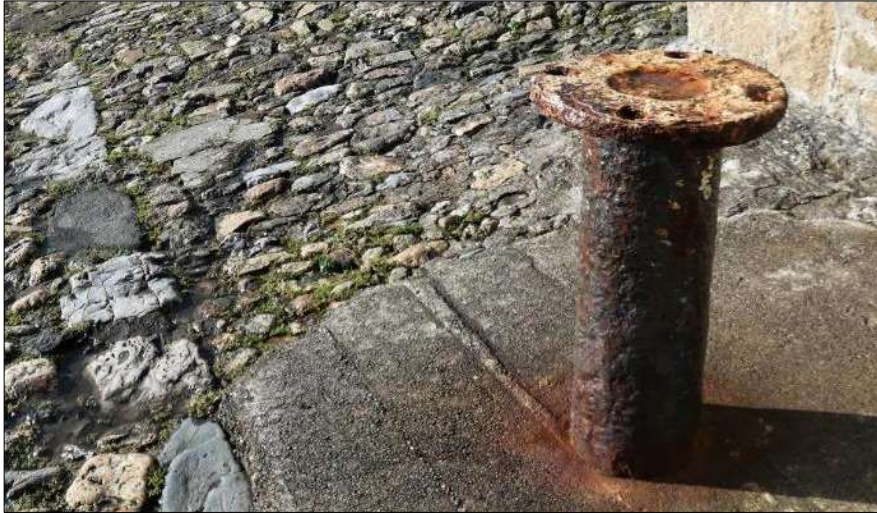
Part of a rising main from a mining or china-clay working reused as a bollard.

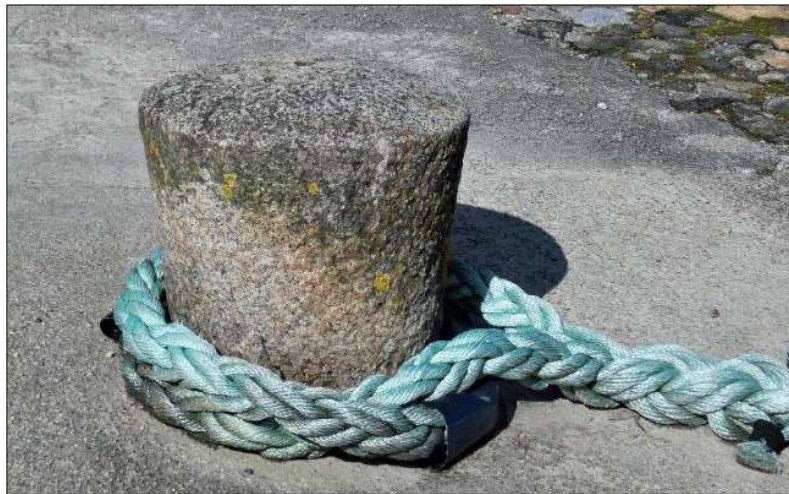
A granite bollard on the outer harbour.

A variety of granite and iron bollards occur along the walls of the outer harbour.

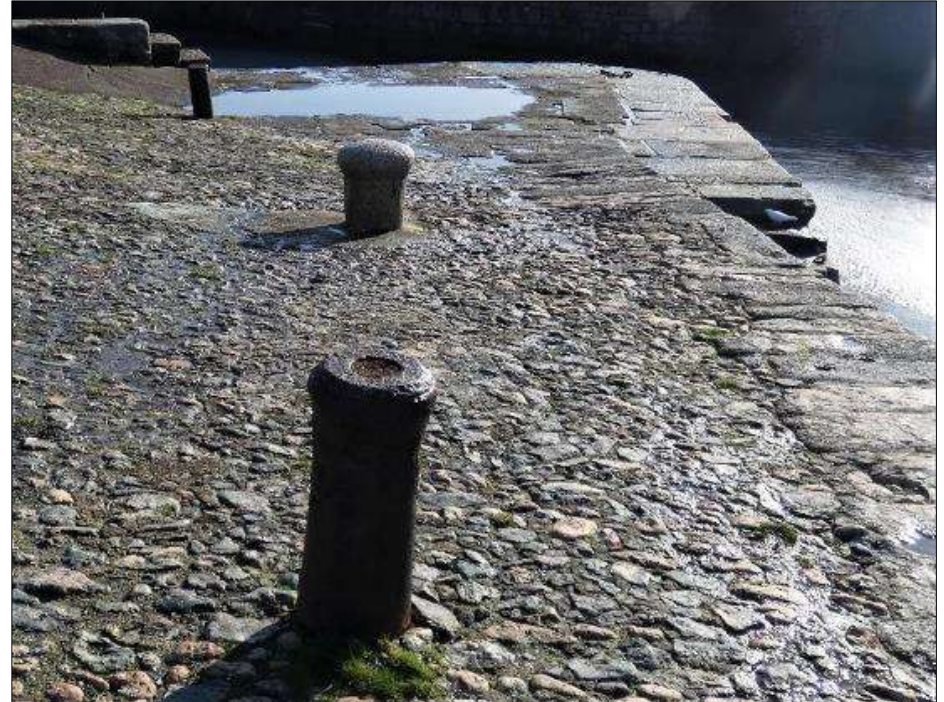
A variety of bollards on the inner basin, including (nearest), the barrel of a small cannon.
