Charlestown Conservation Area Character Appraisal and Management Plan

2020

The document was commissioned by St Austell Bay Parish Council and prepared by Cornwall Archaeological Unit, Cornwall Council.

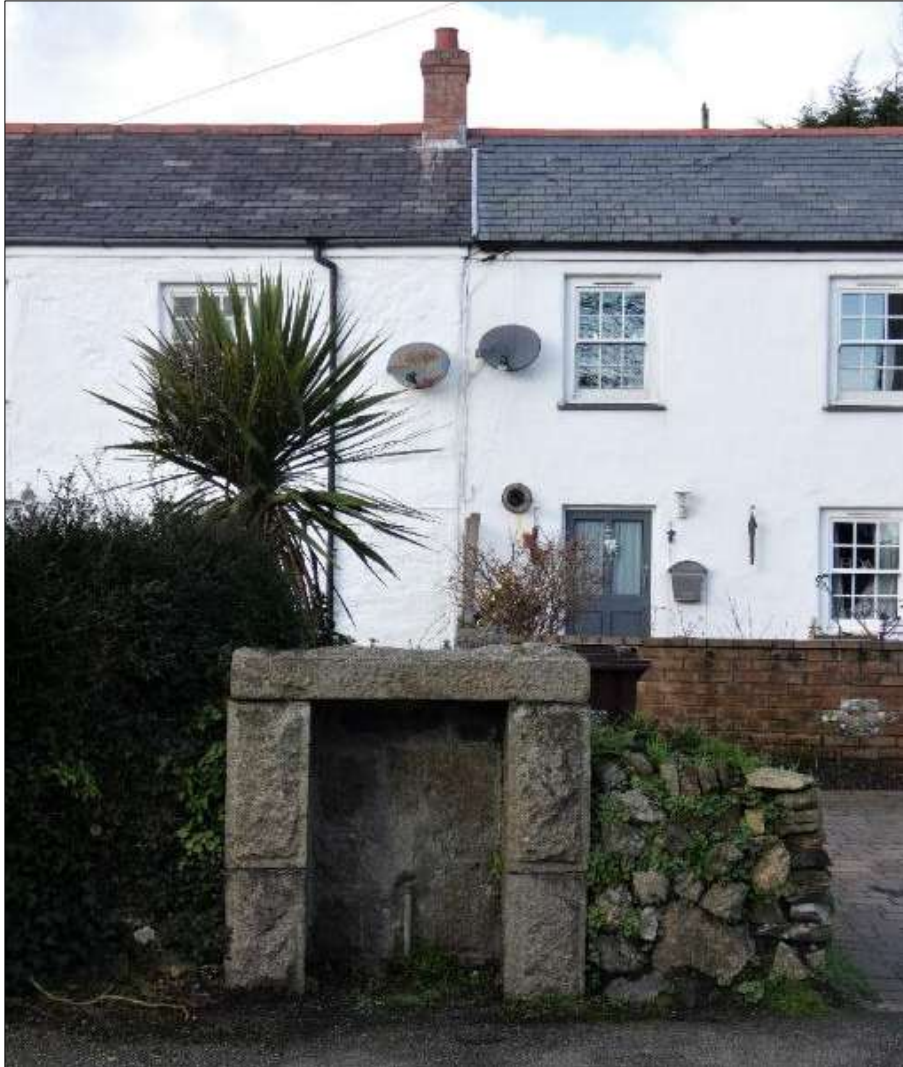
One of Charlestown's distinctive granite niches, constructed in the later nineteenth century to house water supply standpipes to serve nearby dwellings.

Dressed granite niches: These simple but significant structures are found throughout the village and were built to house communal water taps serving particular groups of dwellings.

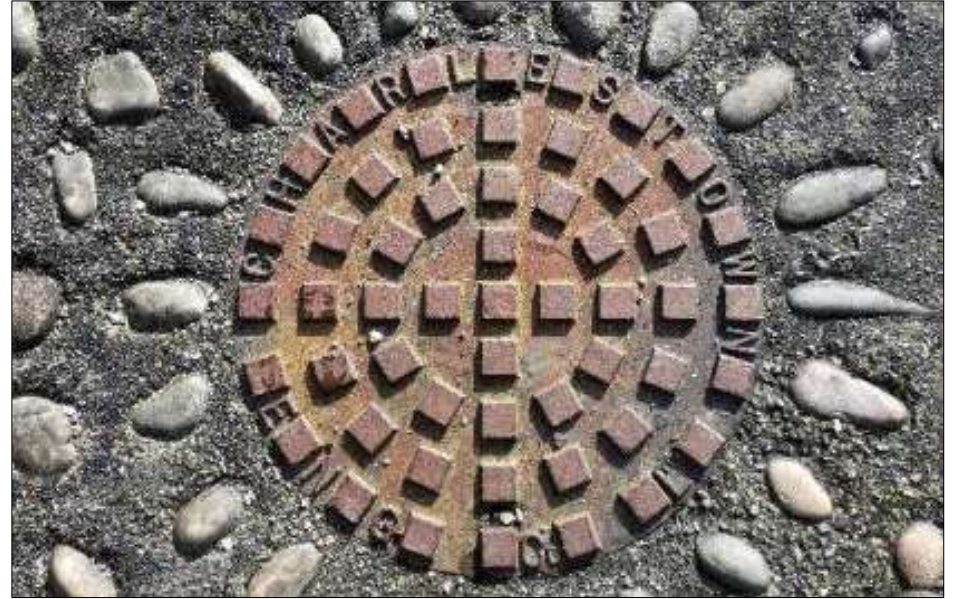
A maintenance inspection cover marked 'Charlestown Eng Co Ltd' within the redeveloped foundry site.

- Several maintenance inspection covers in the area of the redeveloped foundry complex are marked 'Charlestown Eng Co Ltd'.
- Safety railings are a significant visual feature in several places. Around the harbour and along the Coast Path towards the battery they are supported by minimally dressed split granite posts, alongside the leat in Duporth Road by upright lengths of former tramway rail, and adjacent to the Pier House Hotel by pierced iron posts with pointed tops. Lengths of iron railings which survive in places around the harbour and adjacent to the Coast Path are polygonal, possibly hexagonal, in section and are

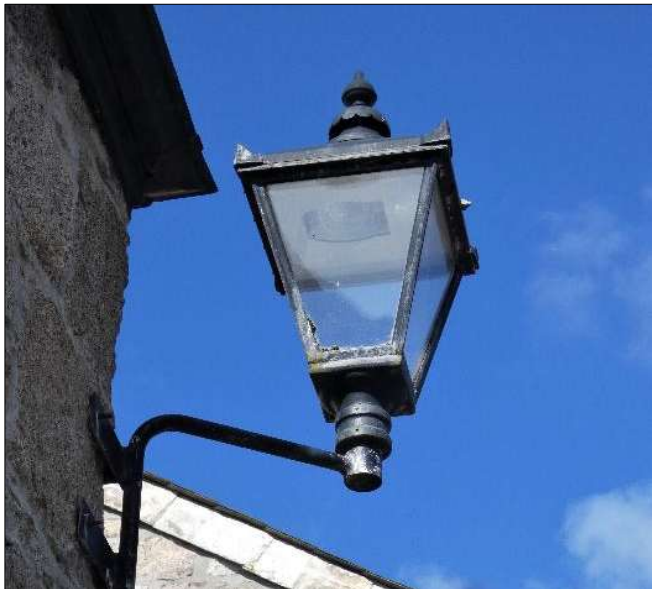
Heritage-pattern bracketed street lighting.

- The heritage-pattern street lanterns fixed to the walls of some of the buildings at the southern end of Charlestown Road and their free-standing equivalents in the same area and on Duporth Road reflect the local tradition of ironwork and are appropriate elements within the high-quality built environment in this area. (They could very suitably be emulated throughout the rest of the Conservation Area.)
- Several large cast-iron anchors, formerly associated with the Shipwreck Treasure Museum, are now displayed around the village, including one as an entrance feature and another on the roundabout adjacent to the head of the harbour.

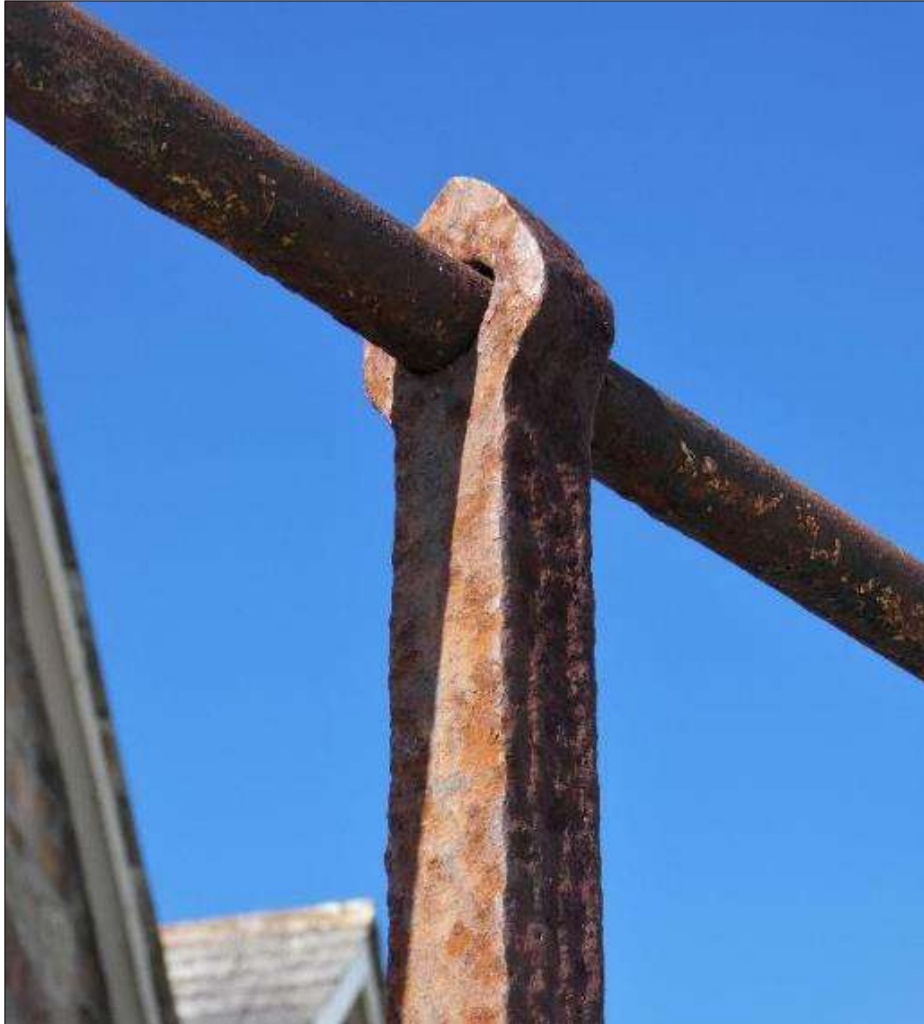
Distinctive iron safety railings on the Coast Path adjacent to the Pier House Hotel.

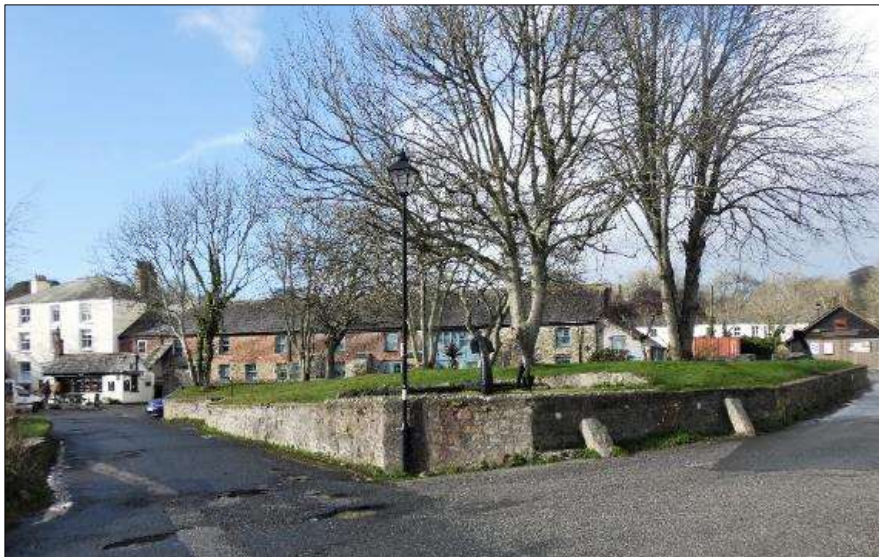
Trees and grass on the cask bank at the north end of the inner harbour soften and lend charm to what is otherwise an area of relatively hard landscaping.

One of the historic cask banks to the north of the inner basin is laid to grass with tree and shrub cover. Self-sown trees, scrub and ivy cover on the revetment to the north end of the harbour also add greenery to the scene but there are concerns about the potential impact on the historic fabric.

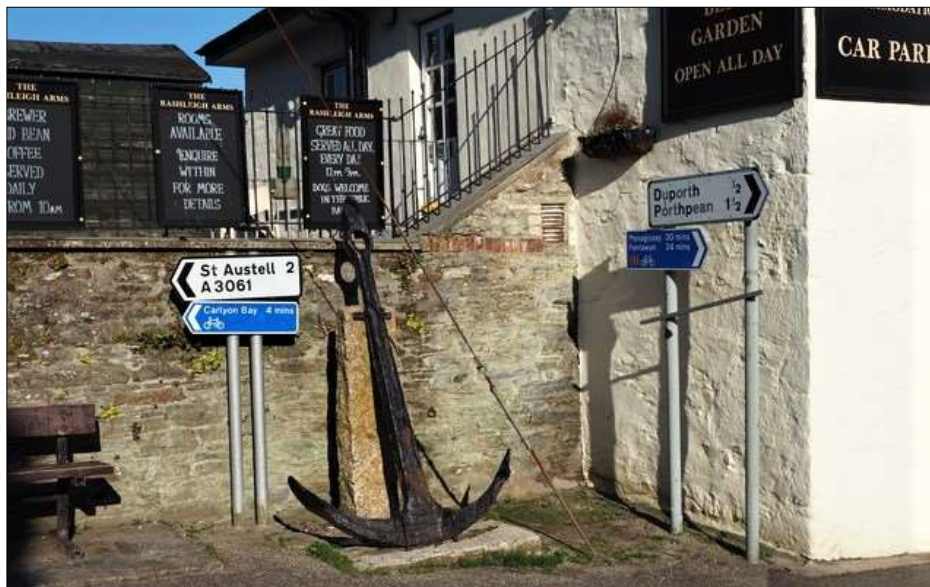
Signage clutter can detract from the surrounding historic fabric.

In several areas, most notably around the harbour and in proximity to the cluster of enterprises catering for visitors, there is an over-provision of street signage, which gives a cluttered and untidy air which detracts from the historic character and quality of the settlement. The frequent signs marking restricted access to areas off the main routeways are also intrusive and again are not always sited with respect for the surrounding historic fabric.

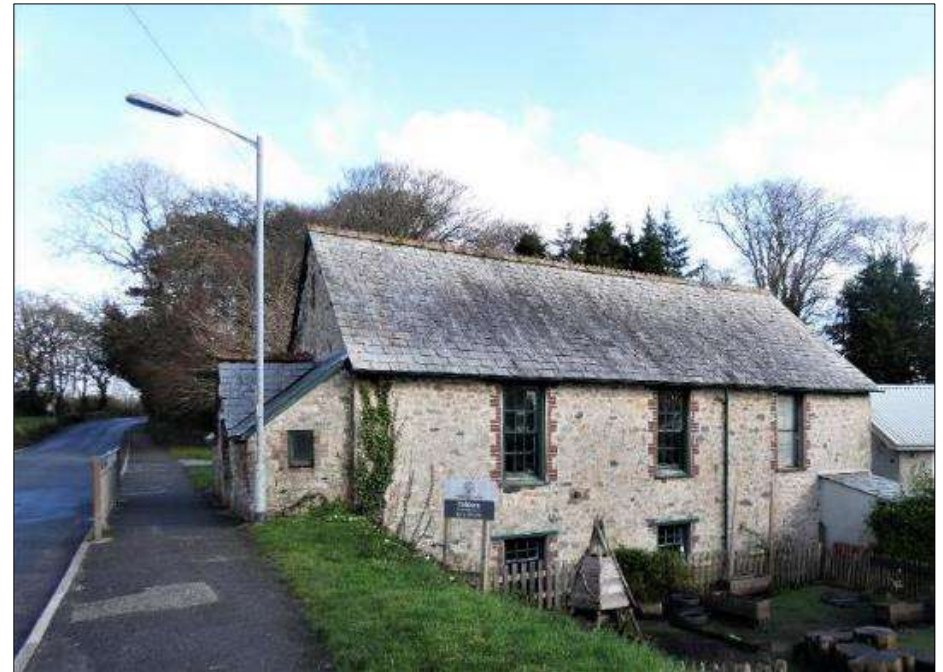
Killas stonework and brick detailing on the former Church of England Sunday School, located on the edge of the churchyard on Church Road. The utilitarian form of the street lighting is inappropriate to the quality of the historic environment and green setting in this area.

The utilitarian streetlights along the northern end of Charlestown Road and on Church Road are over-large and more appropriate to a bypass or other major road than to a sensitive historic location.

- Promote the reinstatement and long-term management of street trees.
- Seek replacement of street lighting inappropriate to the quality and character of the historic environment.

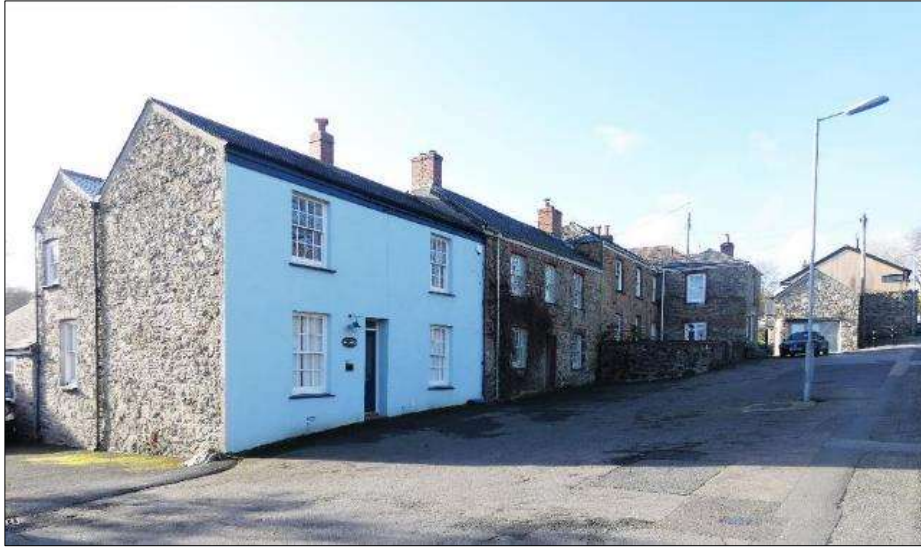
The wide hard-surfaced space fronting 103–109 Charlestown Road was originally a working area forming part of the large West Polmear farm complex. The form and scale of street lighting is inappropriate to the sensitive historic streetscape.

The wide expanse of tarmac in front of nos 91–109 Charlestown Road is to some extent mitigated by the planting of replacement street trees. The open nature of this area reflects its historic character as part of the former farm complex here but the uniformity of the tarmac surface with the road surface is overpowering and may attract vehicle parking, which would diminish the otherwise charming quality of the historic setting.

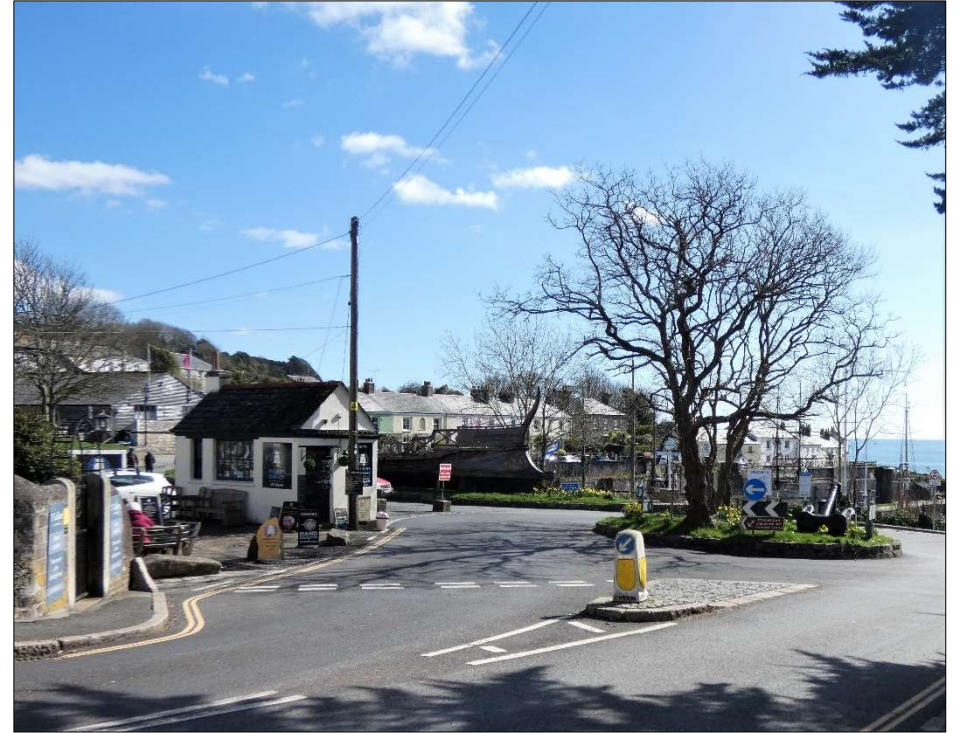
The public realm is cluttered in places, here by a combination of traffic management infrastructure, electricity supply and overhead cabling, a replica galley and commercial signage. The presence of the tree on the roundabout to some extent mitigates and softens the visual impact.

- Predominance of commercial leisure provision, together with vehicle traffic and high visitor footfall, have resulted in public realm clutter, particularly in terms of signage, traffic management infrastructure, seating and randomly placed 'objects'. There is need of a robust approach whereby such clutter can be managed and controlled.

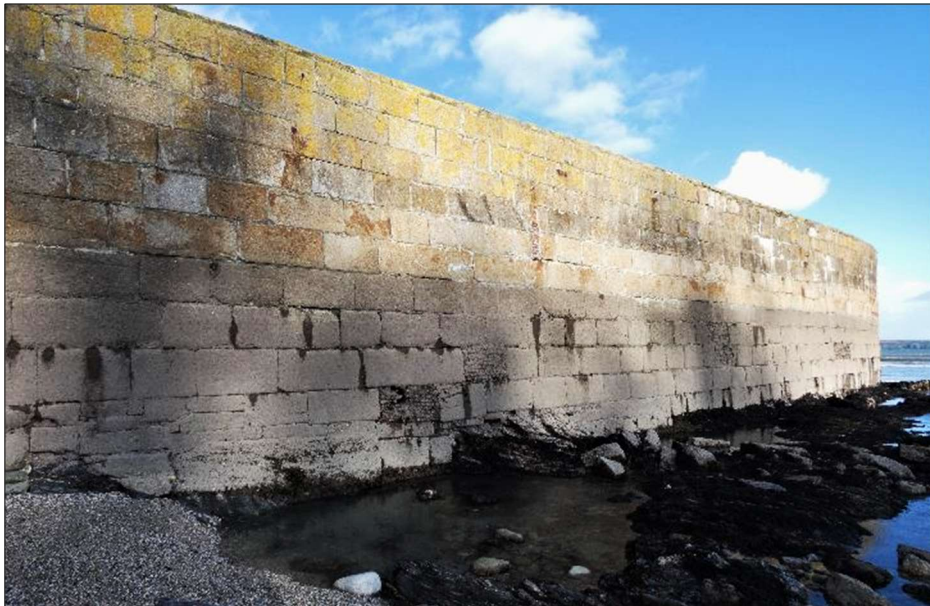
Massive moorstone blocks and old repairs in brick on the seaward side of the Grade II Listed outer harbour wall.*

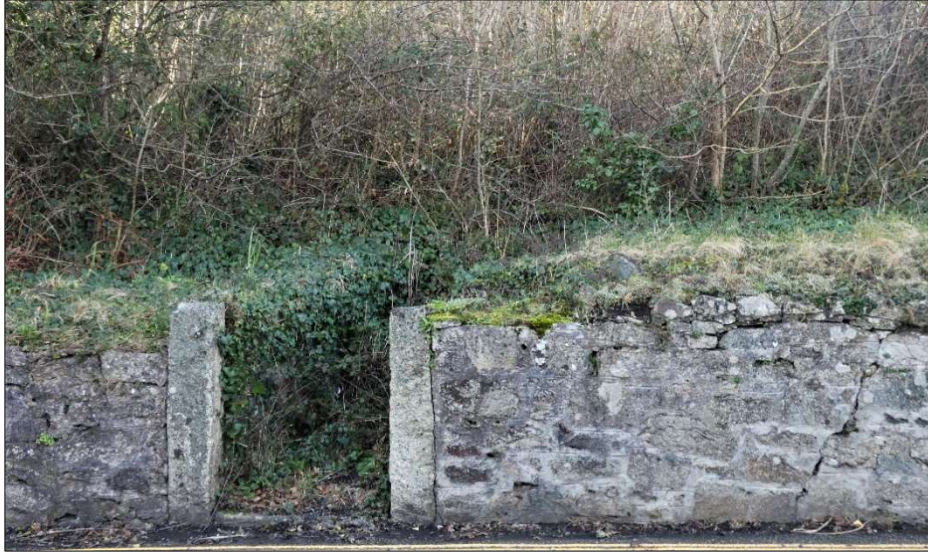
Mortared boundary wall with granite gate piers to the former gardens of the back-to-back houses along Duporth Road. The high visibility of historic boundaries within the Conservation Area means that they merit careful repair to conservation standards, using appropriate methods and materials.

Many prominent boundaries and outbuildings within the settlement require conservation work to avoid further deterioration and potential loss. It is particularly important that characteristic features such as decorative wall cappings are not lost and that appropriate methods and materials are used in patching and re-pointing.

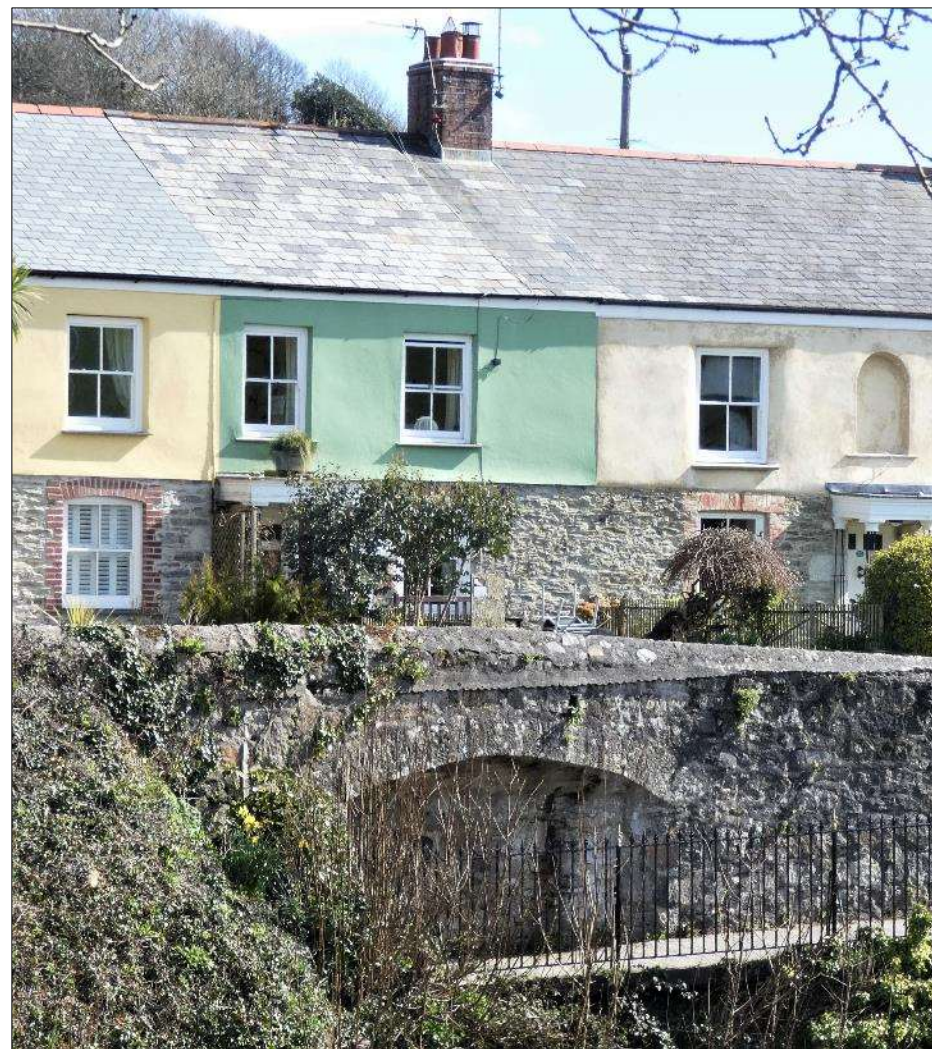
The portal to the tunnel under Quay Road which formerly carried a tramway from the Lovering clay dry to the harbour, a unique feature of Charlestown's history as a china clay port.

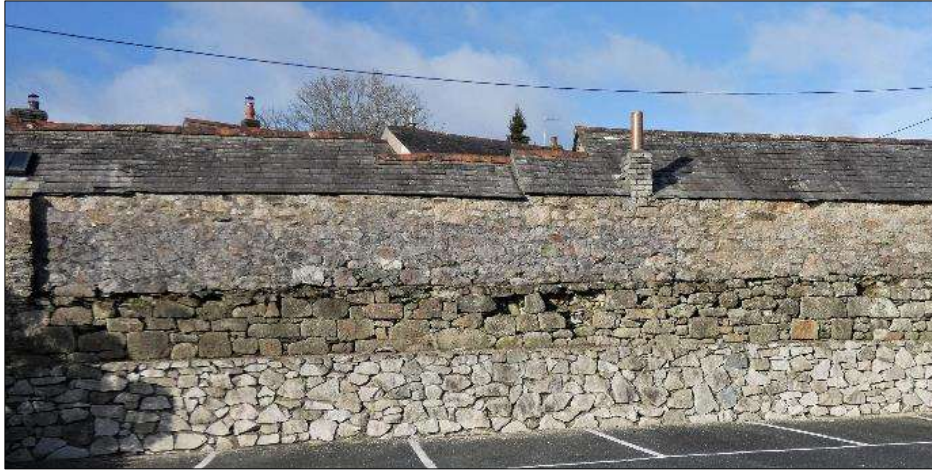
Contrasting historic fabric and modern random stone walling in the main Charlestown car park.

Building materials and techniques used in new constructions and in alterations or extensions to existing ones should be appropriate to the setting and to the highest conservation standards, following the style and character evident in existing buildings and other structures within Charlestown. The erosion of character produced by 'crazy-paving' walling and similar poor-quality pastiches of traditional construction styles has a significant negative impact on the otherwise strong sense of quality and tradition in Charlestown's built environment. In stonework the contrast with traditional forms tends to be emphasised by the use of newly quarried rather than recycled materials.

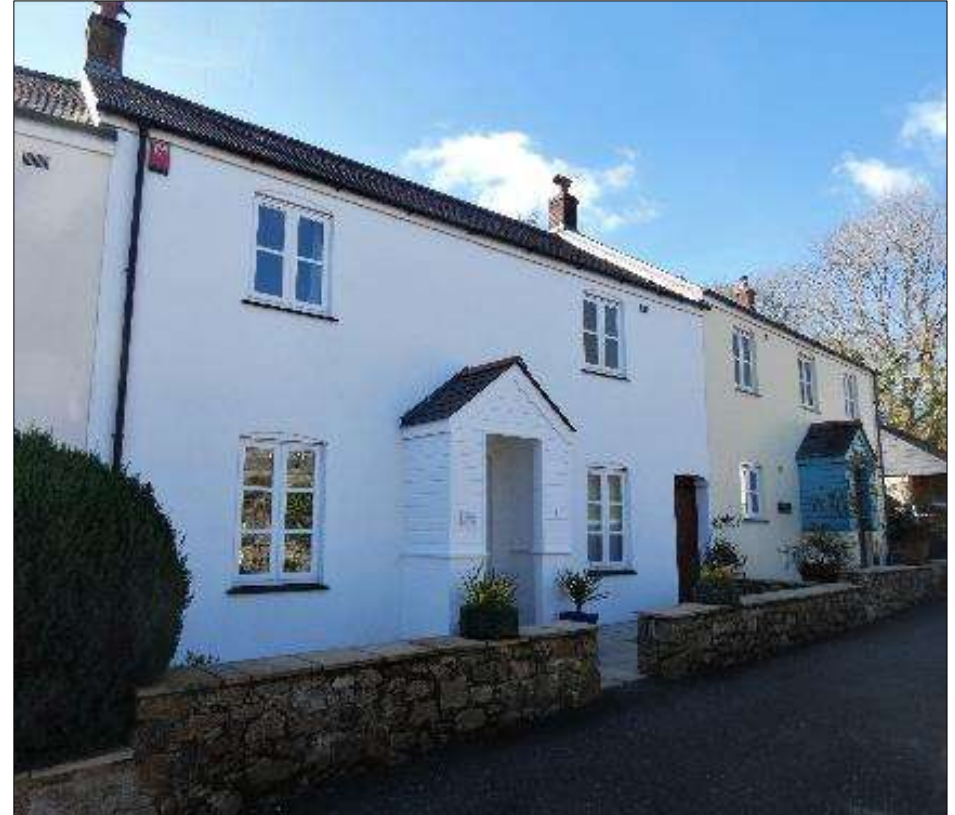
New houses on Barkhouse Lane incorporate elements of distinctive local building traditions.

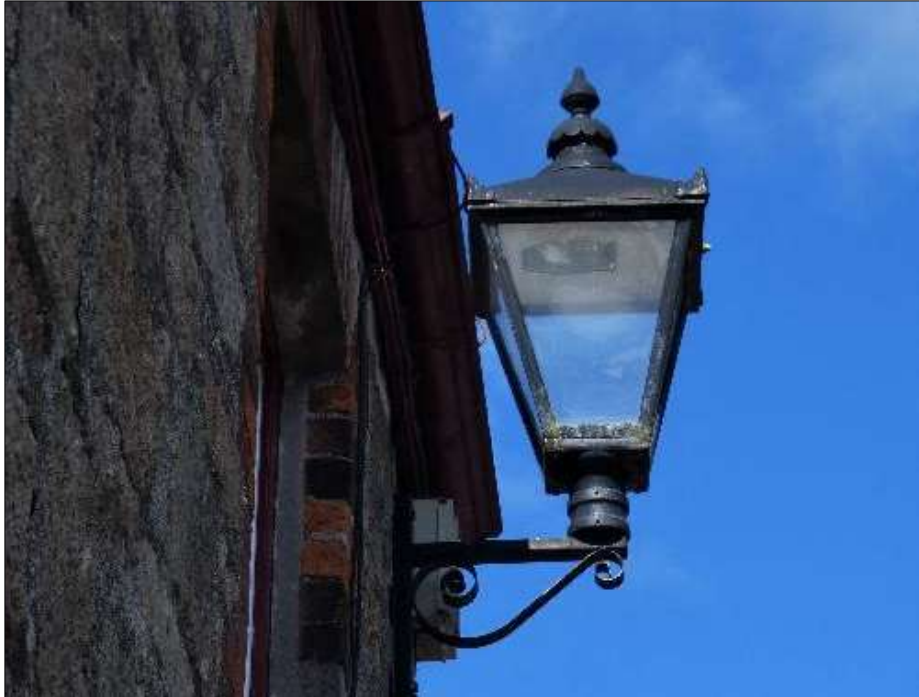
The heritage-pattern lanterns in the lower part of Charlestown are appropriate to the setting and provide effective lighting without additional street clutter.

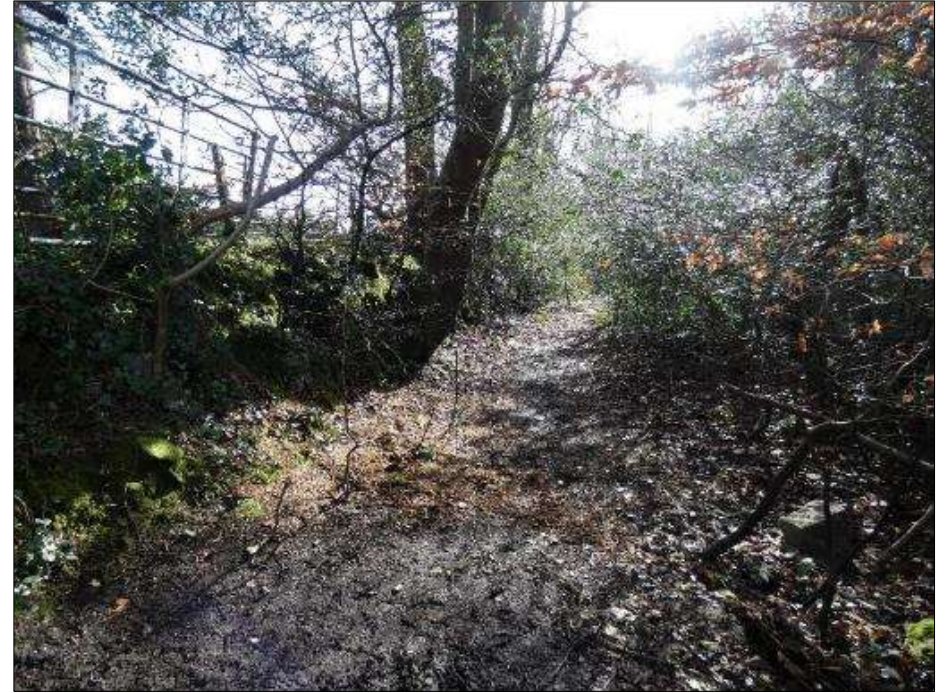
The northern end of the former ropewalk. There is currently no public access.

The possibility of access to the ropewalk, reservoir ponds, leat system and surrounding countryside from within the settlement should continue to be explored, and the conservation of the leats and ponds both in terms of the natural and the historic environment encouraged.

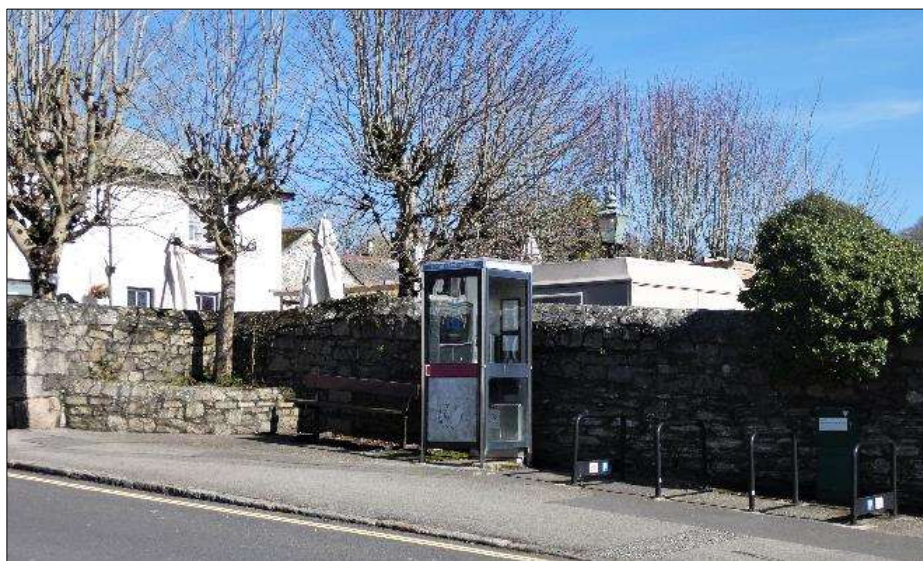
The public realm in some areas has become over-cluttered. The modern cabin-style telephone box near the Rashleigh Arms is not sympathetic to the surrounding historic environment.

Consideration should be given to relocating the modern telephone box adjacent to the Rashleigh Arms to a less obtrusive site or replacing the existing structure with an historic telephone kiosk or a new structure in a simple and appropriate design.

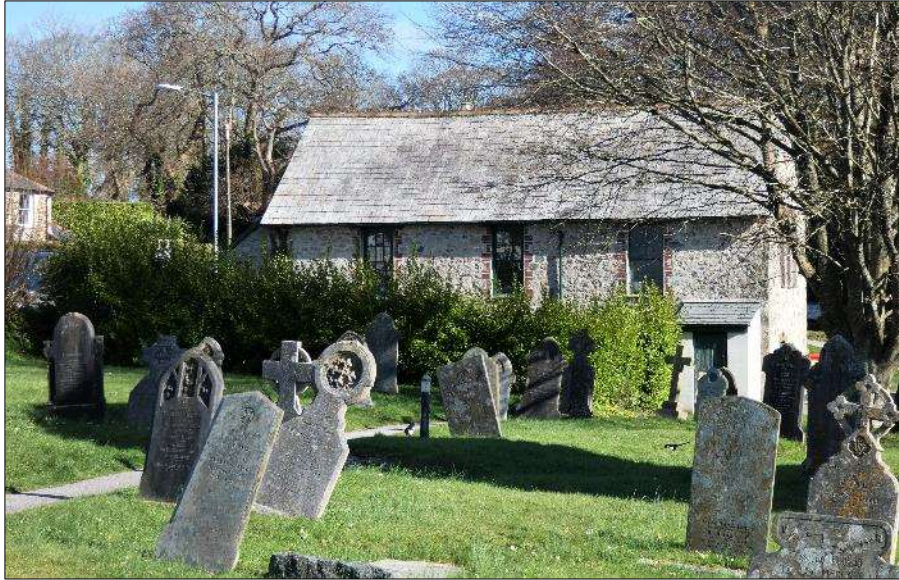
The Sunday School of 1880 at the east end of the graveyard in Church Road.

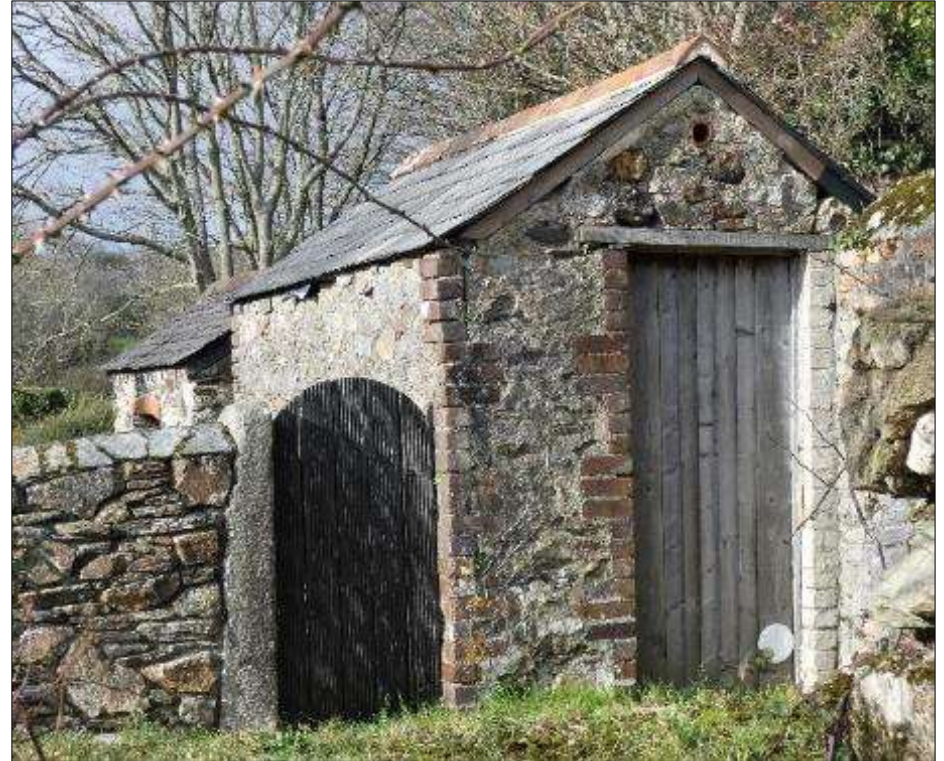
The survival of a variety of historic outhouses, sheds and workshops is a notable element of the historic built environment in Charlestown.

Good survival of minor structures – outhouses, washhouses, privies, small stores, workshops and sheds – is a key character attribute of Charlestown. Usually constructed of vernacular materials, they offer evidence of former ways of life but also maintain the sense of a busy, working, industrial and industrious settlement, with evidence of historic activity even in otherwise secluded corners.

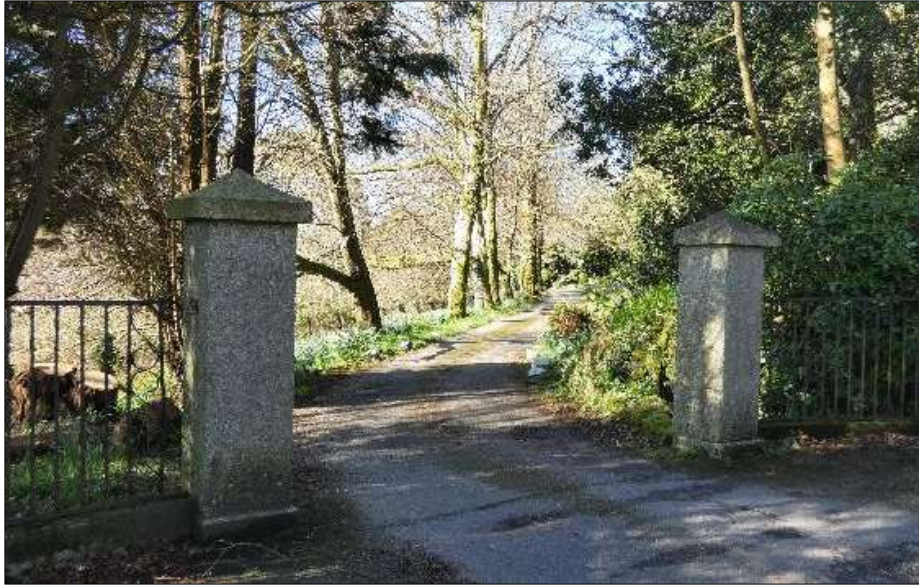
Granite gate piers with pyramidal caps at the entrance to The Grove.

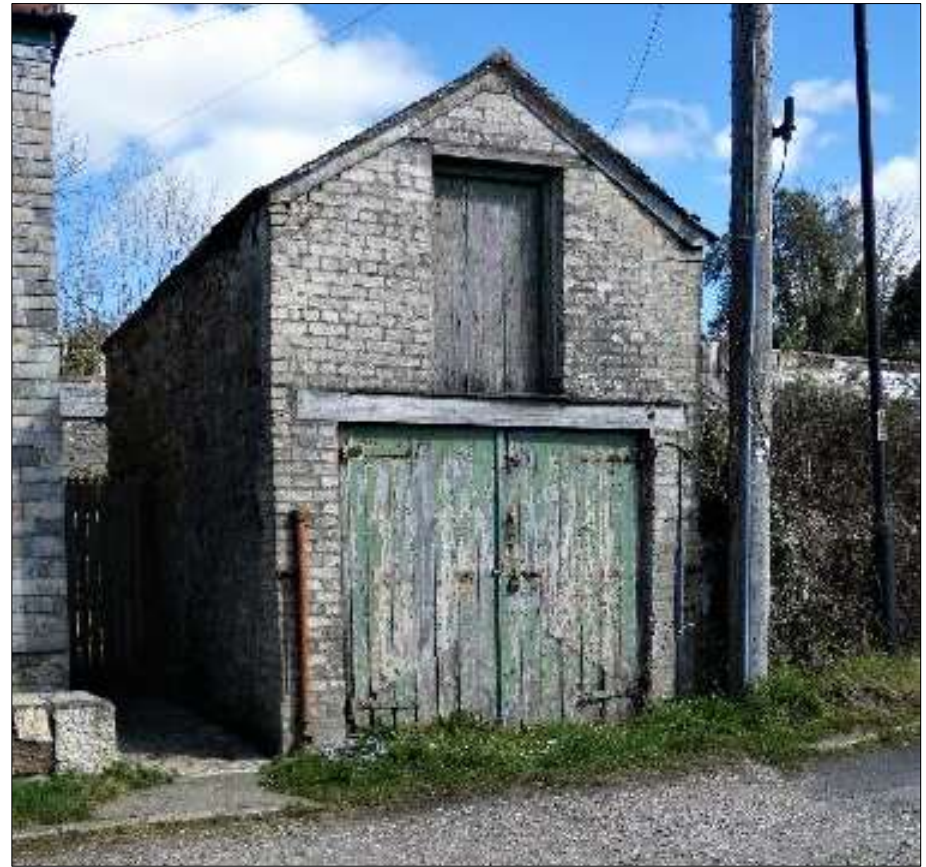
A workshop or store on Quay Road.

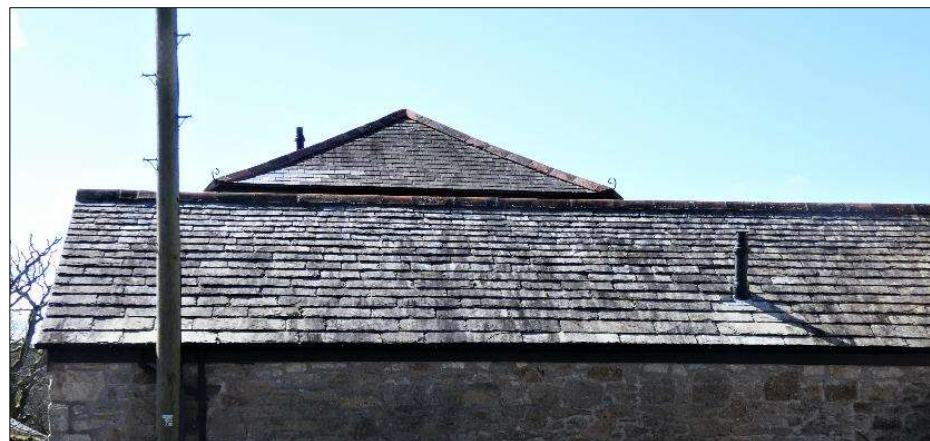
A scantle slate roof in a prominent position alongside Charlestown Road.

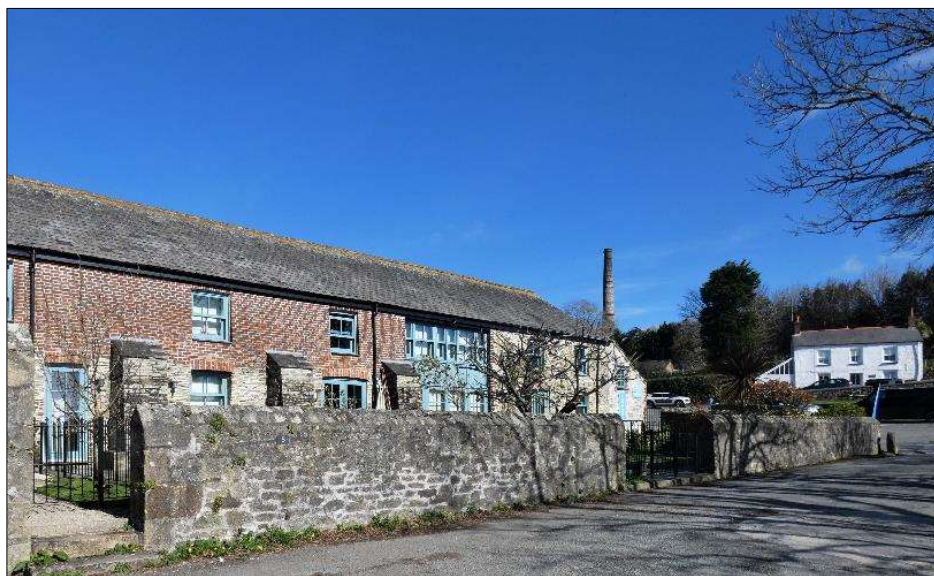
Prominent use of brick in the Duck Street row.

There are few historic buildings in Charlestown entirely constructed from brick. However, it was used extensively on later buildings and outhouses in the form of lintels, decorative window surrounds, quoins and chimneys, and is prominent on the façades of the Granary and Polmear farmhouse and in buildings such as the Count House and the Duck Street cottages. The use of lime mortars for repair is equally important for brickwork.

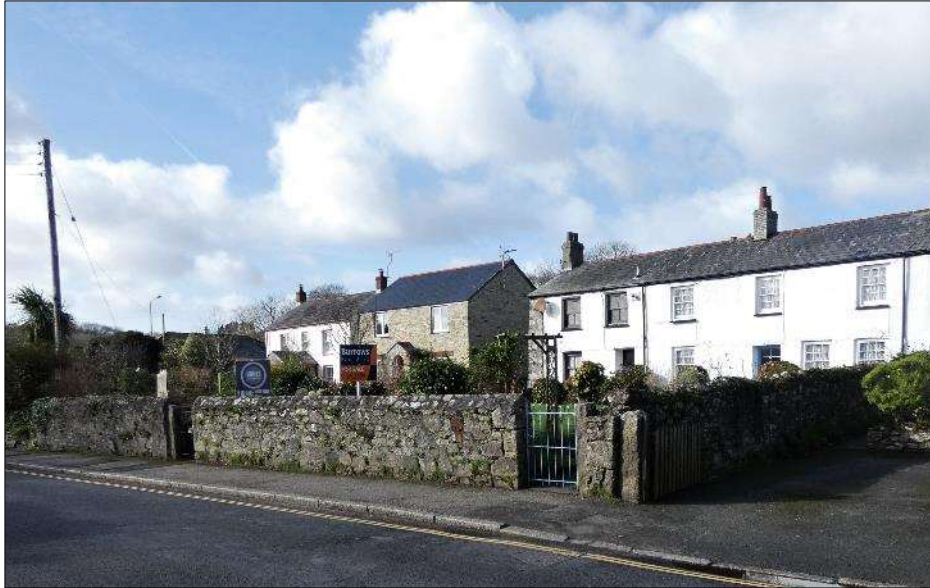
Surviving and removed stone boundaries in Church Road.

Stone walls, both boundary and retaining are the most common means of enclosure in the village and are a significant contributing factor to the character of the Conservation Area. The majority are constructed from granite or killas with a simple stone cap. Most are mortared and, in some instances, coursed or semi-coursed. There are also examples of Cornish hedges, stone-faced earth banks with soft vegetated cappings.

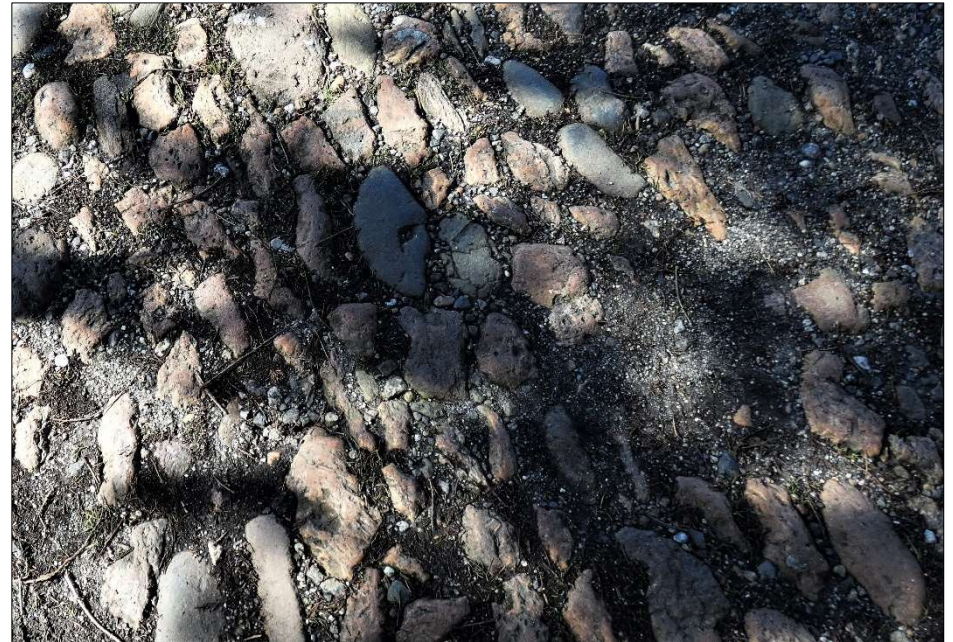
Detail of the ore floor surface exposed in the main car park.

As detailed in the accompanying Conservation Area Assessment, there are a number of different surviving historic floorscape treatments reflecting the selection of local materials available. These include water-rounded beach cobbles, rough metalling, granite kerbing and granite paving. All historic surfaces should be appropriately maintained and restored where possible.
